# 120 SOUTH FAIRCHILD BUILDING STUDY

10-28-16

# 1. Condition Assessment

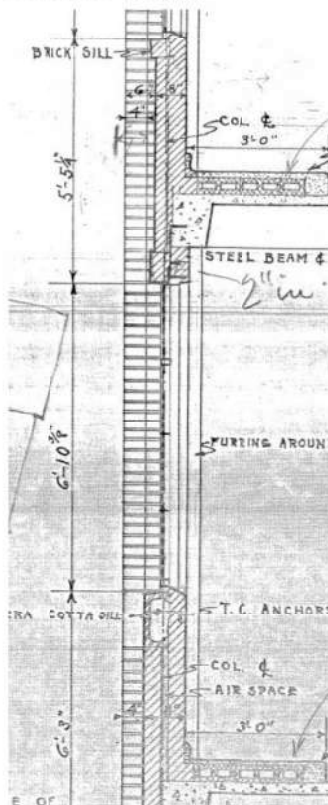
Figure 5 – Original wall section

The primary exterior wall construction is the original construction and consists of red clay brick which is ornamented with white terracotta tiles. The brick and terracotta covers the concrete and steel structural frame. The exterior wall is an infill between the structure and it is a double wythe of brick with a minimal airspace. There is no apparent insulation within this construction so it has very little R-value.

The exterior walls had an extensive repair completed in 2013. The work included tuck pointing to the window sills, tuck pointing and replacement of brick at the lower walls next to the side walk and general brick replacement around specific columns. Visual inspection by a masonry restoration contractor has identified that there are several areas that would require additional work to preserve the envelope. Some of this work would require additional tuck pointing, repairs to the terra cotta and areas where brick would need to be removed and replaced. See **Exterior Elevations** for detailed locations of areas.

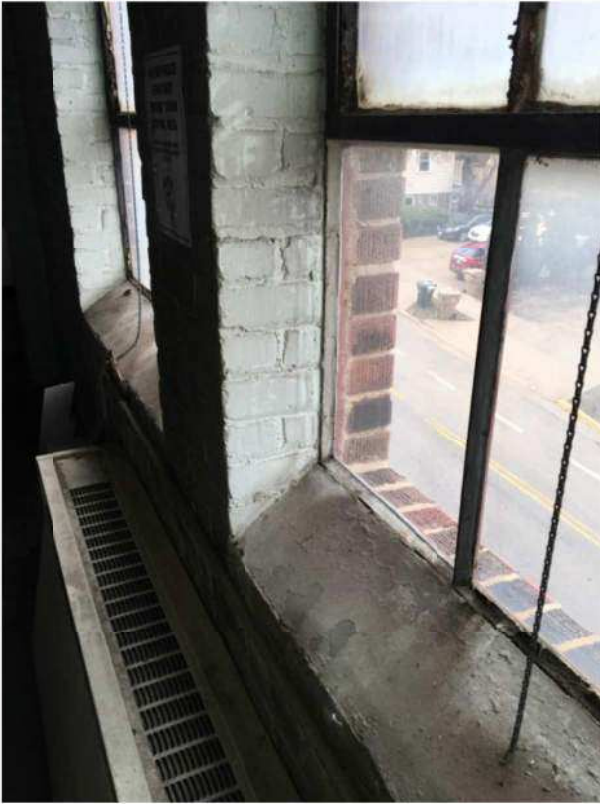
Figure 6 – Exterior window & wall thickness detail

The exterior windows are from the original construction and are divided lite steel sash style with single pane glass. Most units have an operable panel in the central portion and have difficulty sealing properly. The frames are rusty and perimeter caulk around the frame is deteriorating. It appears that individual glass panes have been replaced in many units over the years. With this construction the windows have very little thermal resistance.

Many of the units have been covered with plywood on the exterior either for security reasons or for the inclusion of a mechanical louver at some time (see **Exterior Elevations** for locations). Some of the covered windows have rigid insulation located between the plywood and frame. The windows are in poor condition and depending on the use should be replaced.

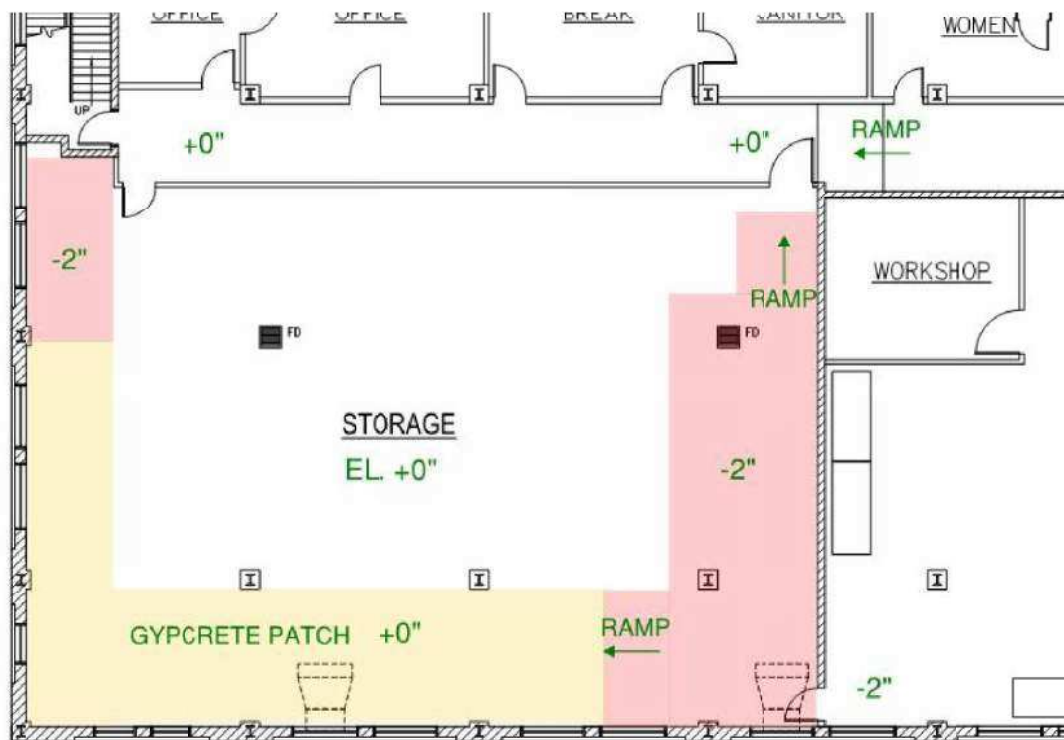
Figure 7 – Concrete topping repair

On the first floor in Storage Room F the concrete topping is in varying condition and it appears that it was patched at an earlier undetermined time. In the Southwest corner and North end of the room it has been removed all together and tapered concrete is used within this room to make the offset transition at two locations. Additional concrete removal and repair in this area will need to be completed.
