## 2. Physical Condition

Institution | City of Madison  
 Building Name | Fairchild Building  
 Building Number | 120 South Fairchild Street

### PHYSICAL CONDITION ASSESSMENT

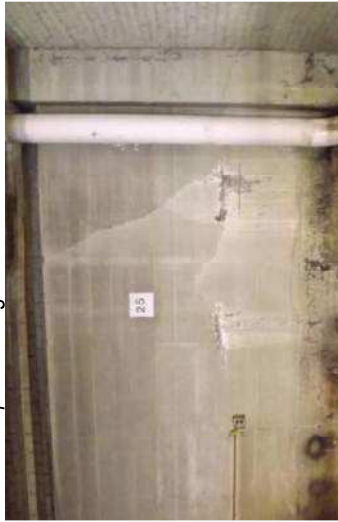
Figure 1

CODE	ITEM	DESCRIPTION	QTY	UNIT	COND.	REMARKS
<b>A</b>	<b>STRUCTURE</b>					
<b>A10</b>	<b>Foundations</b>					
A1010	Standard Foundations	Consist of spread and strip footings. At north side, exterior footings strap with interior for tight lot line.			i	It appears foundations are performing satisfactorily as there is no apparent signs of settlement
A1020	Special Foundations	None				
<b>A20</b>	<b>Subgrade Enclosures</b>					
		Combination of cast-in-place concrete and masonry walls. Primarily, masonry is only used where the is or was some exposure to the exterior, above grade.			i	Generally these walls are in good shape. There is some moisture ingress in the Henry St. stairwell, right near where exterior sidewalk grade is located. There is one concrete wall panel on the north side at the basement area, where some cracking had occurred in the past and there had been some moisture leakage. It is possible this cracking occurred due to temporary pressures during construction of the parking structure. Other past moisture ingress is apparent at the masonry basement wall on the Henry St end.  Figures 1 & 2

Crack and past leakage at north foundation

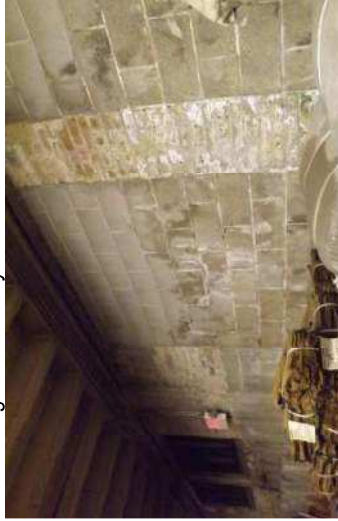
Figure 2

Moisture ingress at Henry St foundation

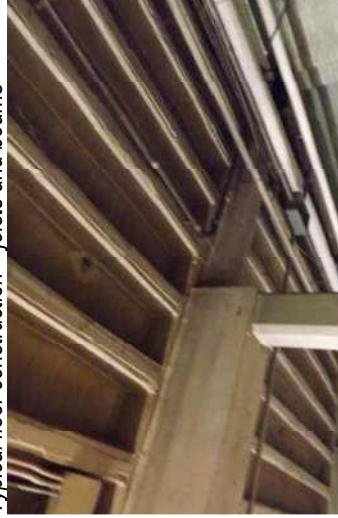
Figure 6

Typical floor construction – joists and beams

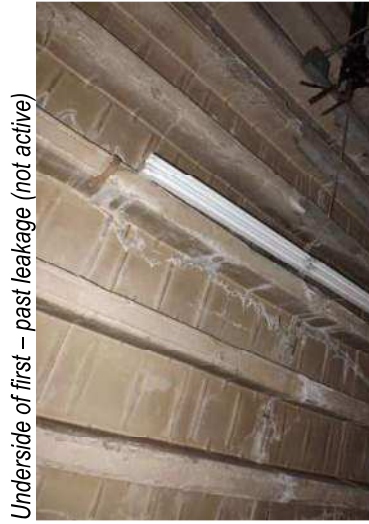
Figure 7

Underside of first – past leakage (not active)

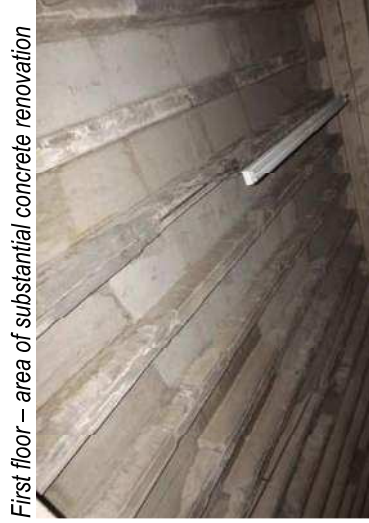
Figure 8

First floor – area of substantial concrete renovation

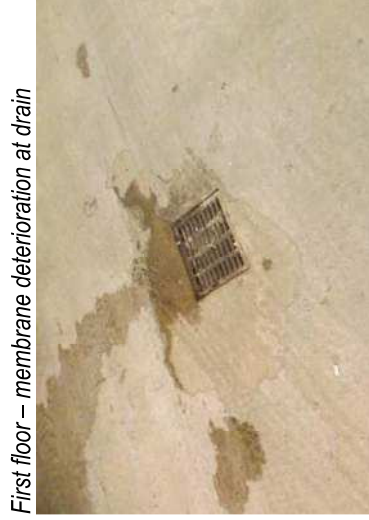
Figure 9

First floor – membrane deterioration at drain

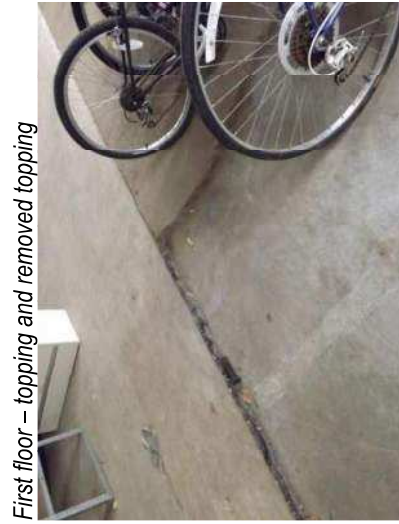
Figure 10

First floor – topping and removed topping

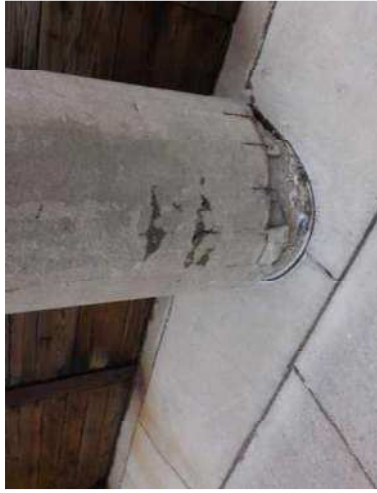
Figure 13

Column base deterioration

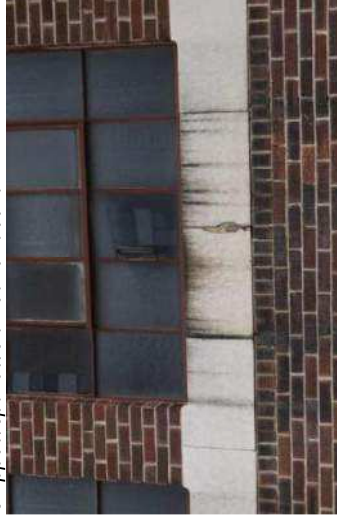
Figure 15

Chipped/spalled/stained terracotta

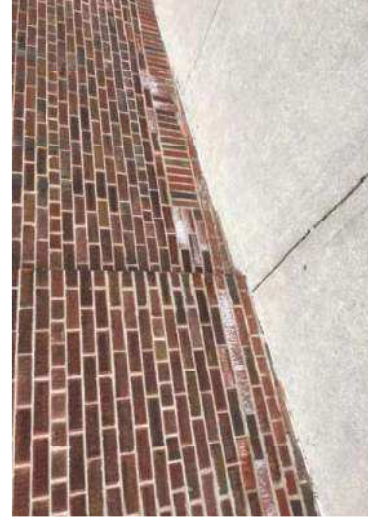
Figure 15b

Caulk joint failing at brick and sidewalk

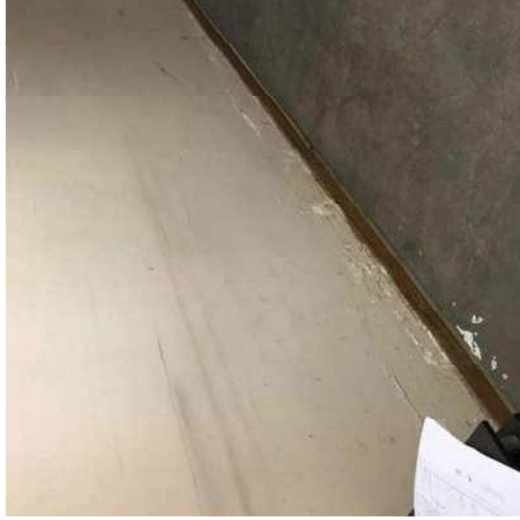
Figure 54 – Plaster over cmu wall damage

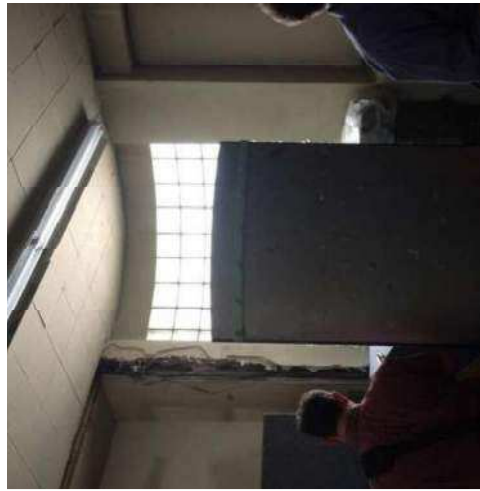
Figure 55 – Plaster damage @ glass block

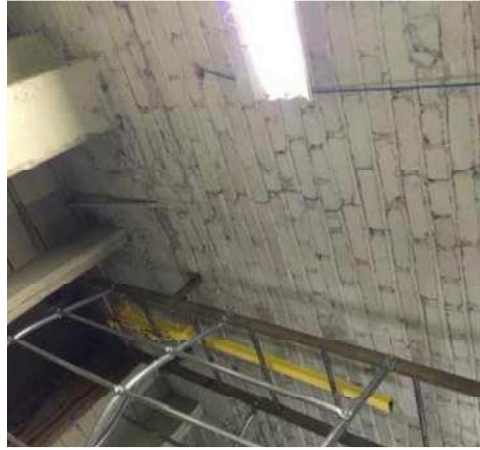
Figure 56 – Stress cracks in brick wall @ SW stair

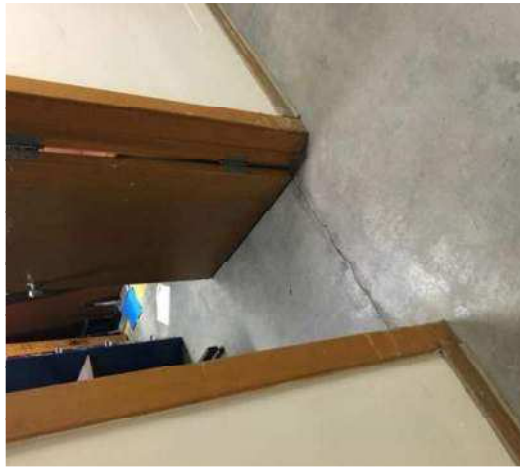
Figure 63 – Conc floor cracks

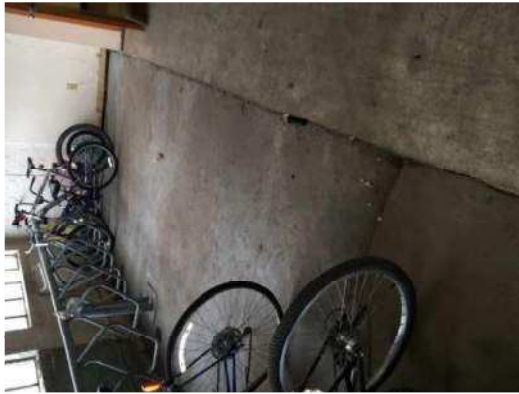
Figure 69 – Concrete slab missing at First floor South wall

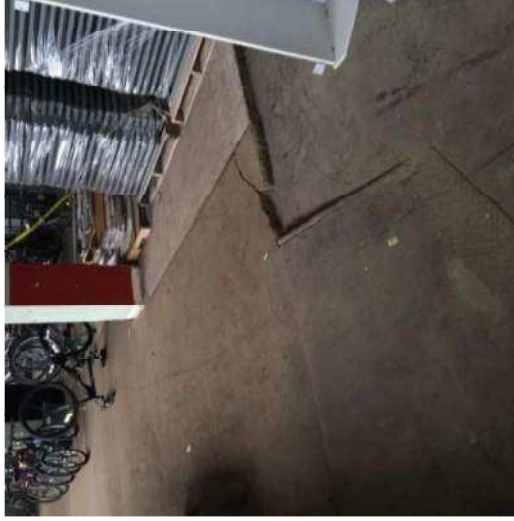
Figure 70 – Concrete slab offset with ramp
