**RAILROAD ARCH CULVERT  
PRELIMINARY ASSESSMENT  
GLENWOOD CHILDREN'S PARK  
MADISON, WISCONSIN**

# Railroad Arch Culvert Preliminary Assessment

## Glenwood Children's Park, Madison, WI

June 5, 2018

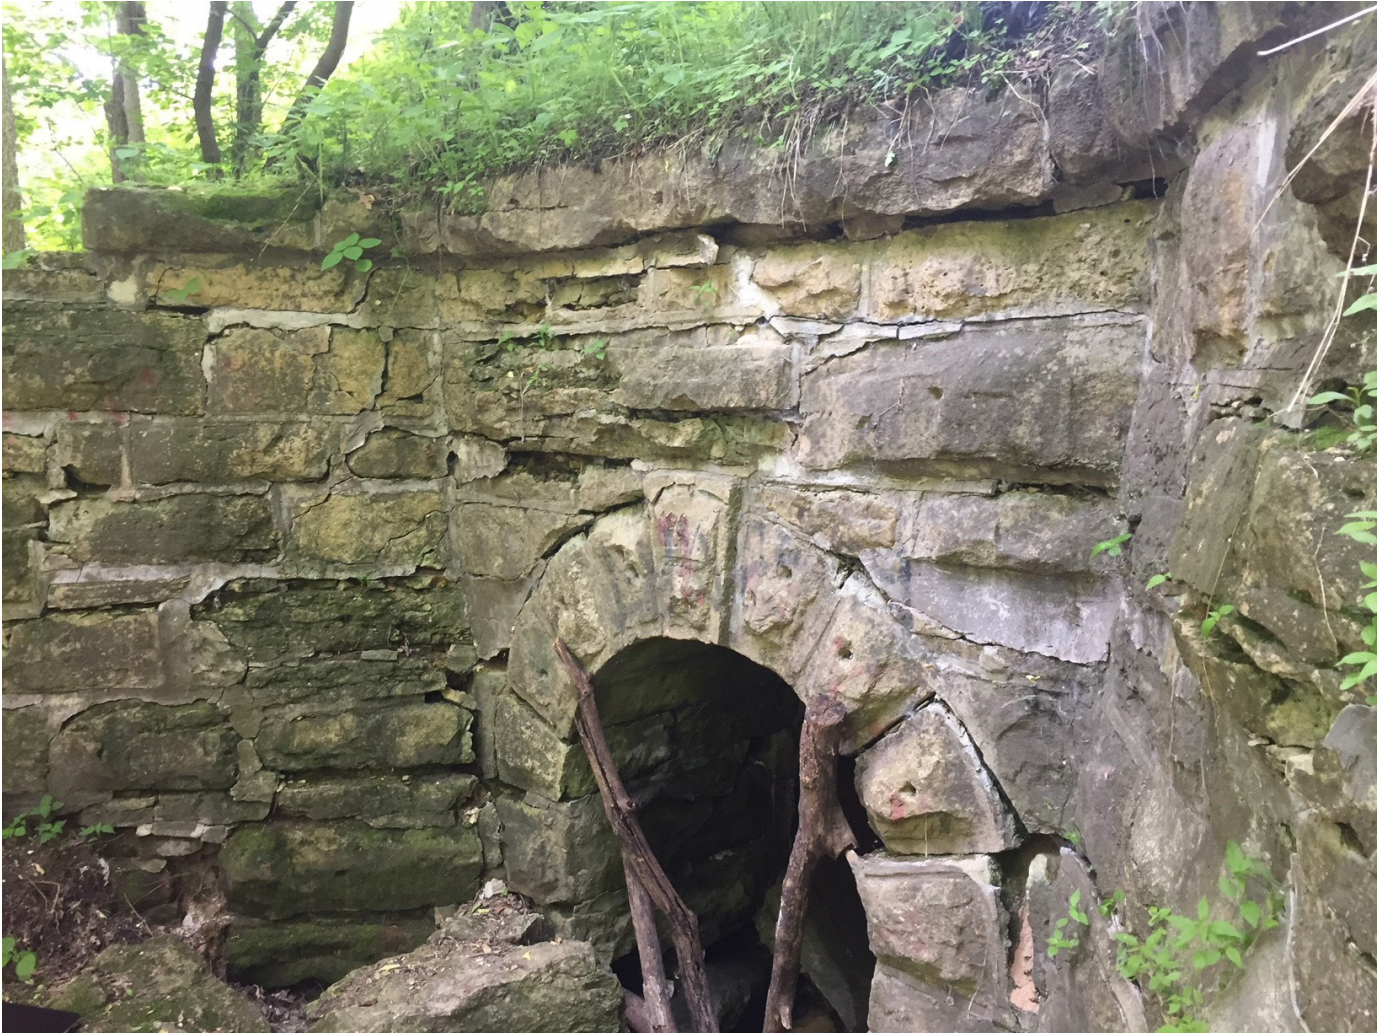
*Figure 1: Height of arch and overburden above.*

Overall rough dimensions:

Height varies maximum ~8-9'

Central arch wall width varies: ~ 7' at base, ~13' at top

Wing-walls (splay backwards going up) at base: ~15' w.

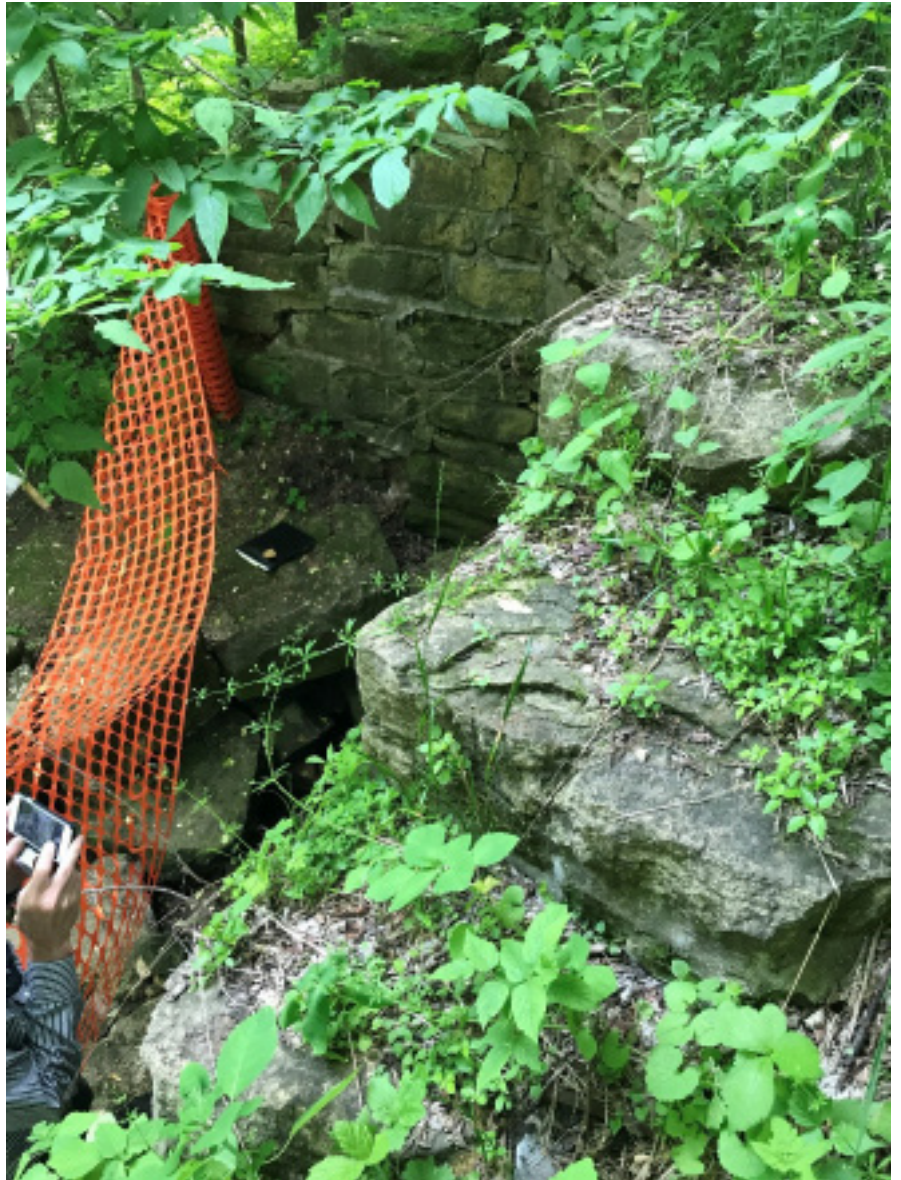
*Figure 2: View of capstones and minimal overburden above the wing walls (additional soil over the ventral arch wall.)*

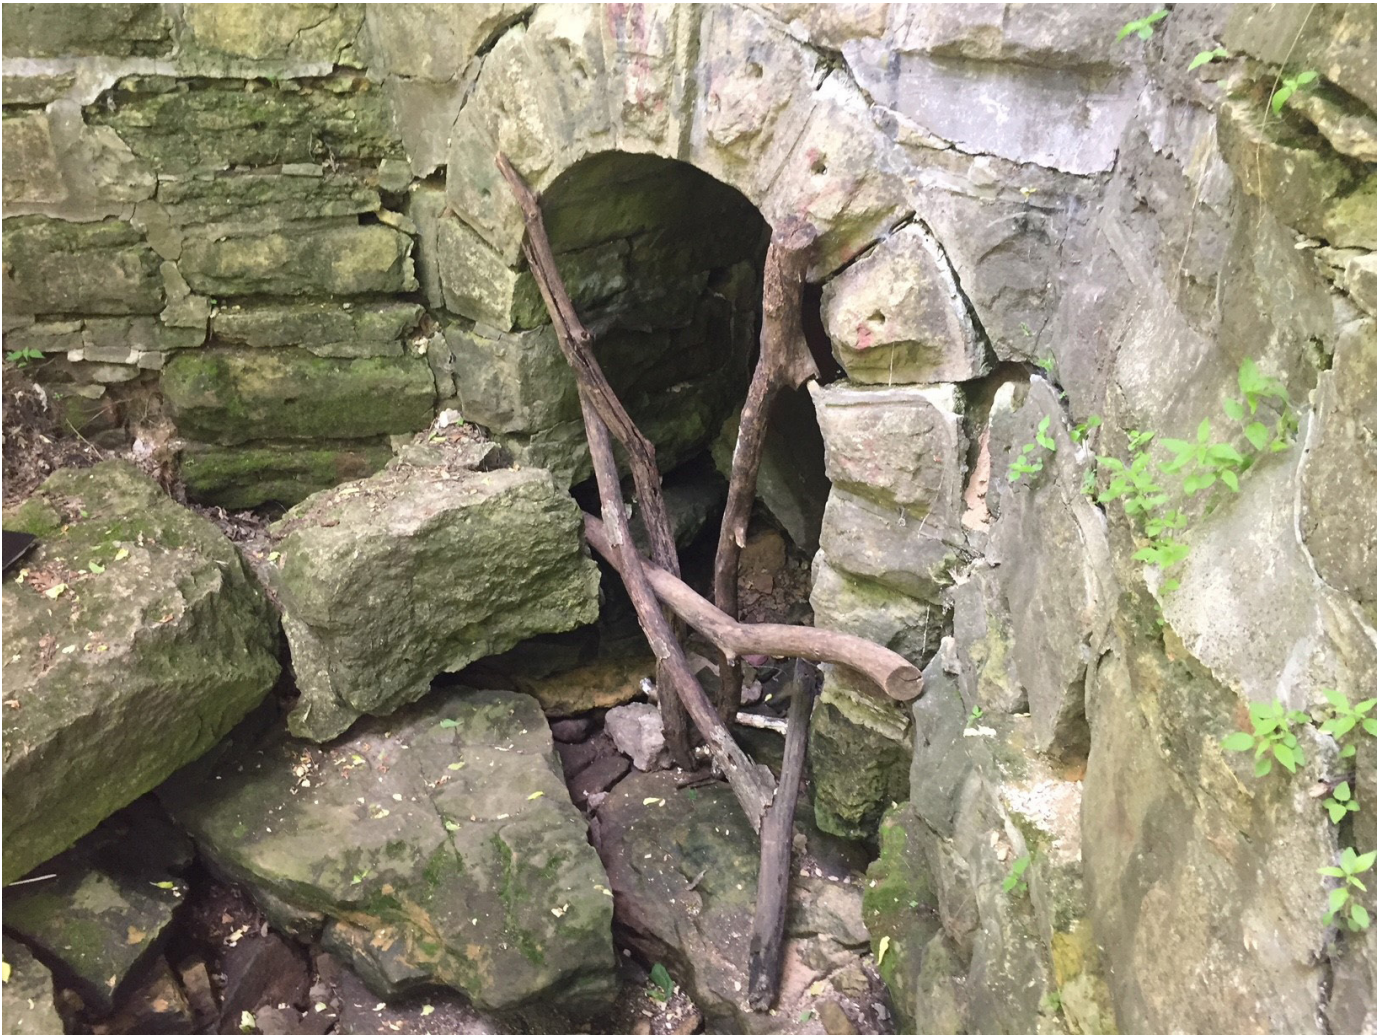
Figure 3: Overall view of arch.

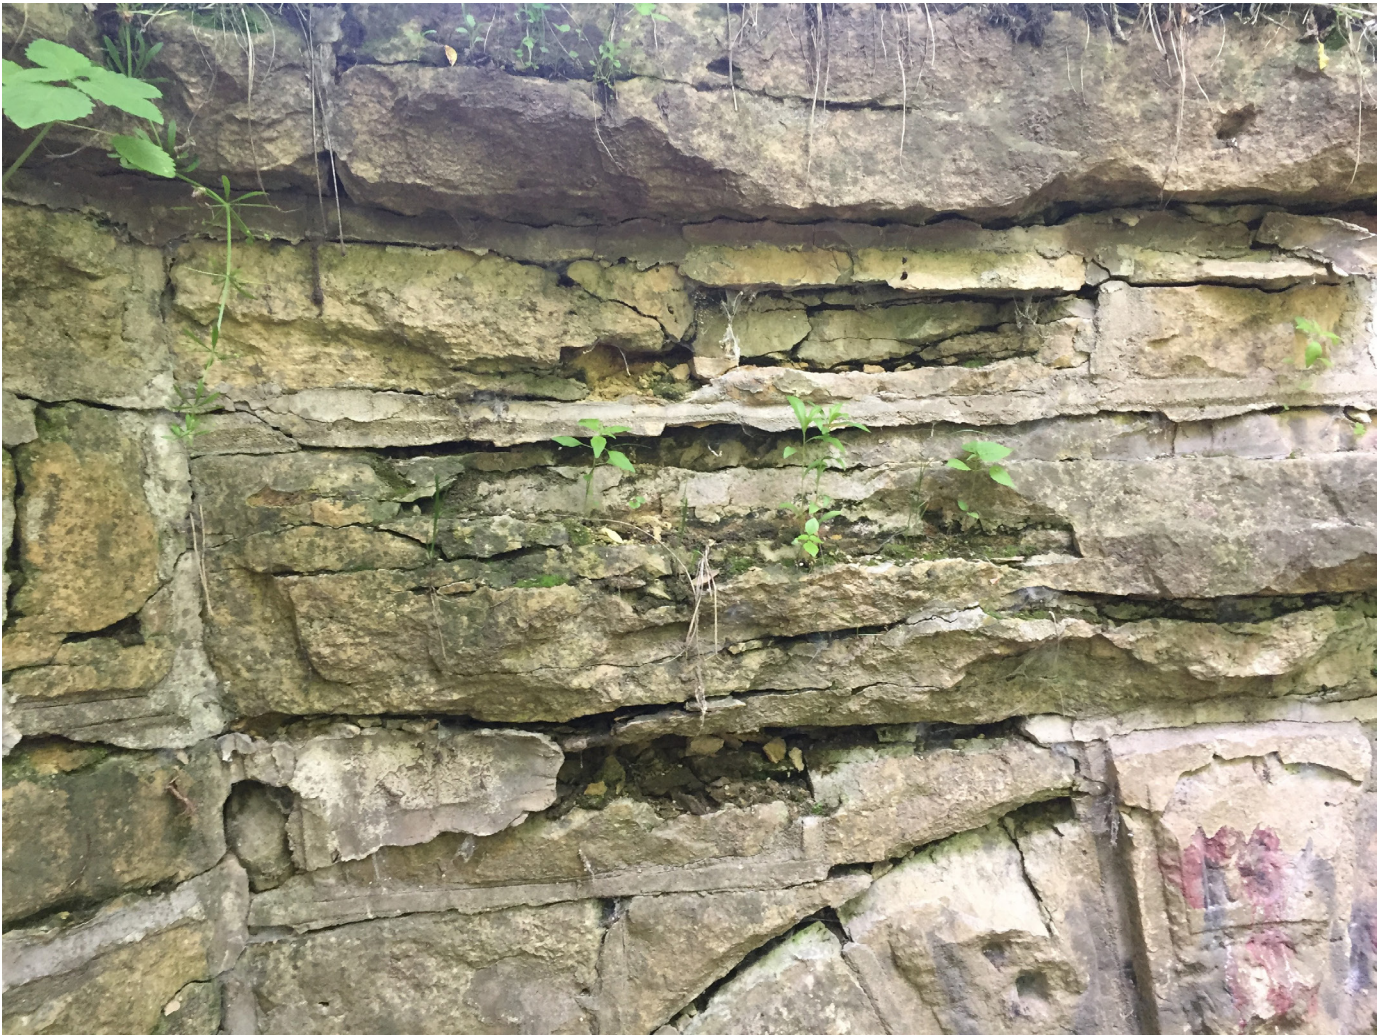
The ashlar blocks of the arch are in better condition than the flanking stones that are in more direct contact with soil and may have been cut from less cohesive sandstone. The consistency of the sandstone varies from easily crumbled to touch to more solid on dryer faces where stone is not perpetually wet.

Figure 4: General disintegration of stone above the arch.

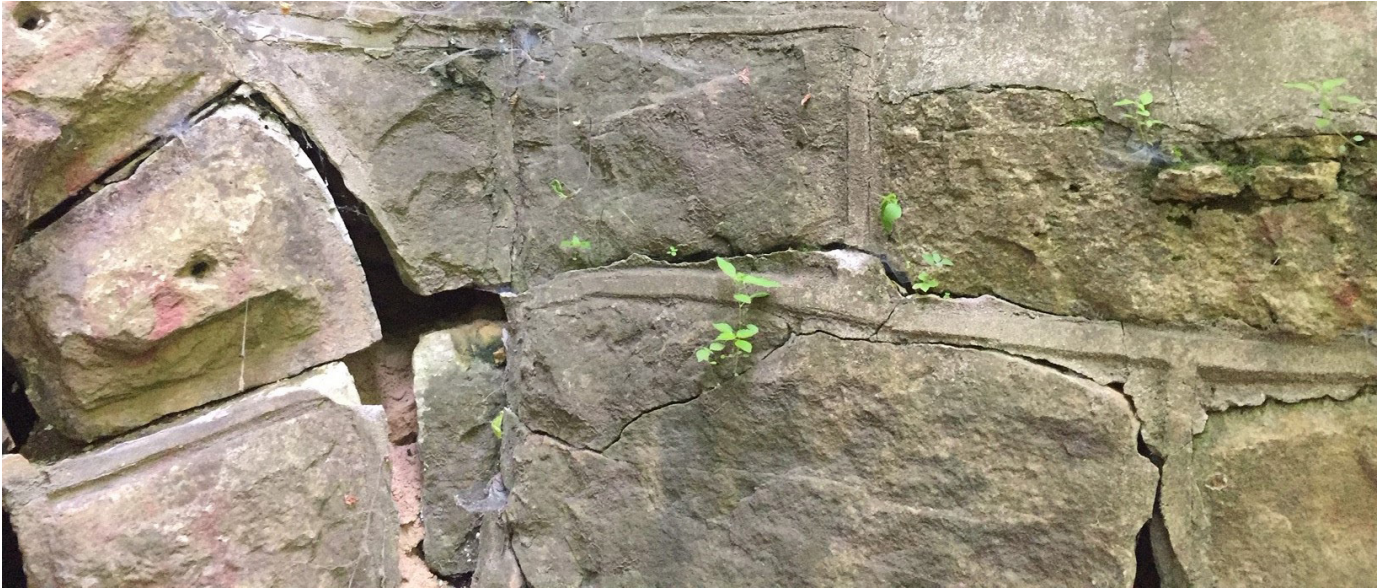
The settling and degradation of the base and surrounding stone is causing misalignment of the inner arch. Many of the surrounding stones are disintegrating so rapidly that only the mortar left suspended in space outlines where the stone head and bed faces had been.

*Figure 5: Right side of arch deflection and beginning of collapse.*

The conclusion is that the entire masonry structure must be deconstructed and rebuilt as soon as funds are available. The stones of the inner arch are in good enough condition to be used as templates to fabricate replacements (as required). The face rustication includes the original lifting holes which add interest and still might be usable in disassembly.

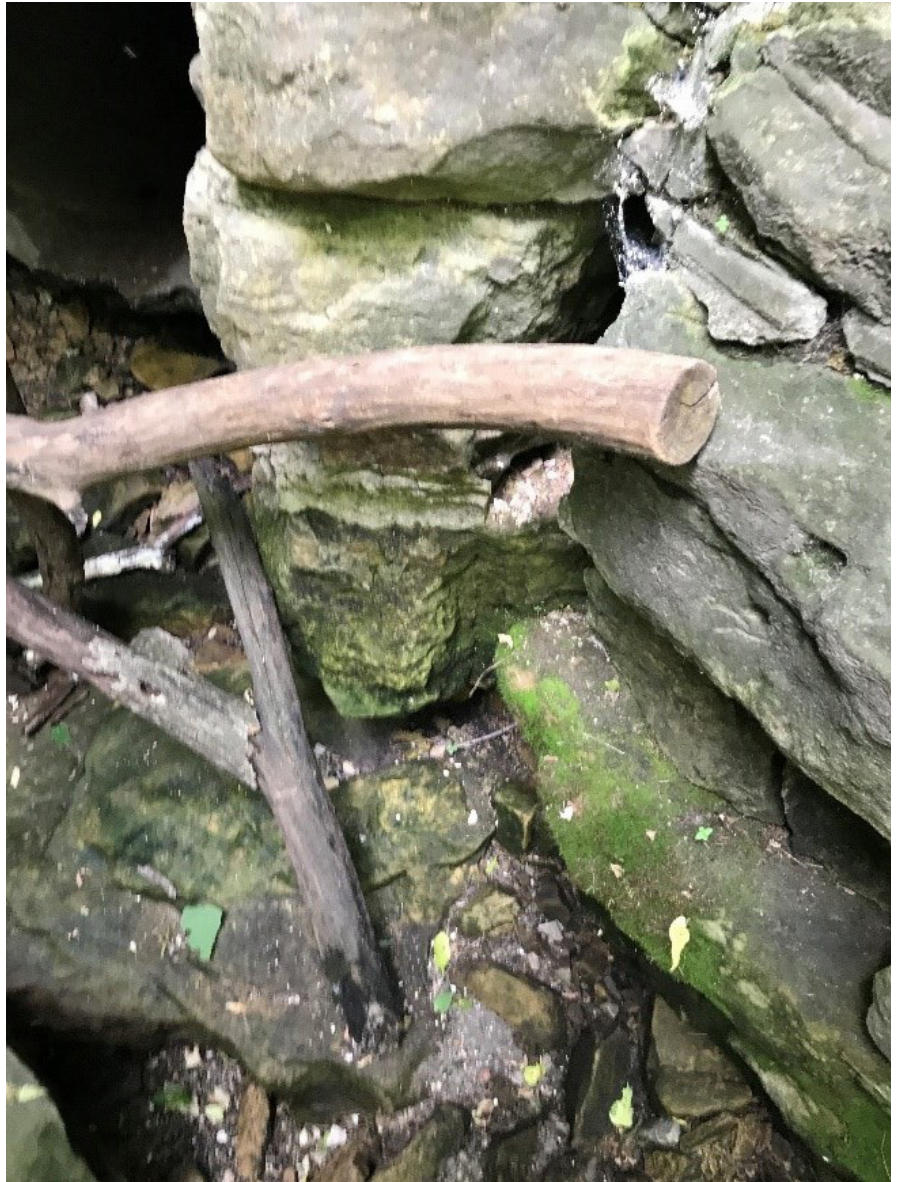
*Figure 6: Arch bearing condition at right.*

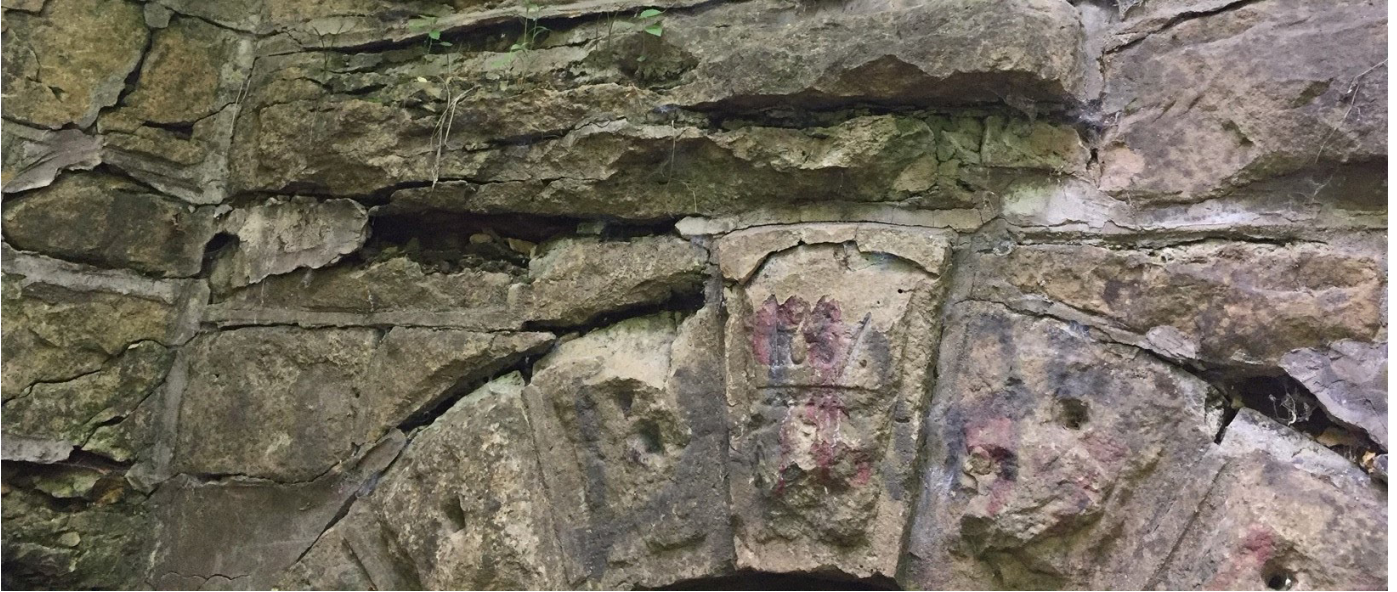
*Figure 7: Defaced Keystone needs to be deciphered.*

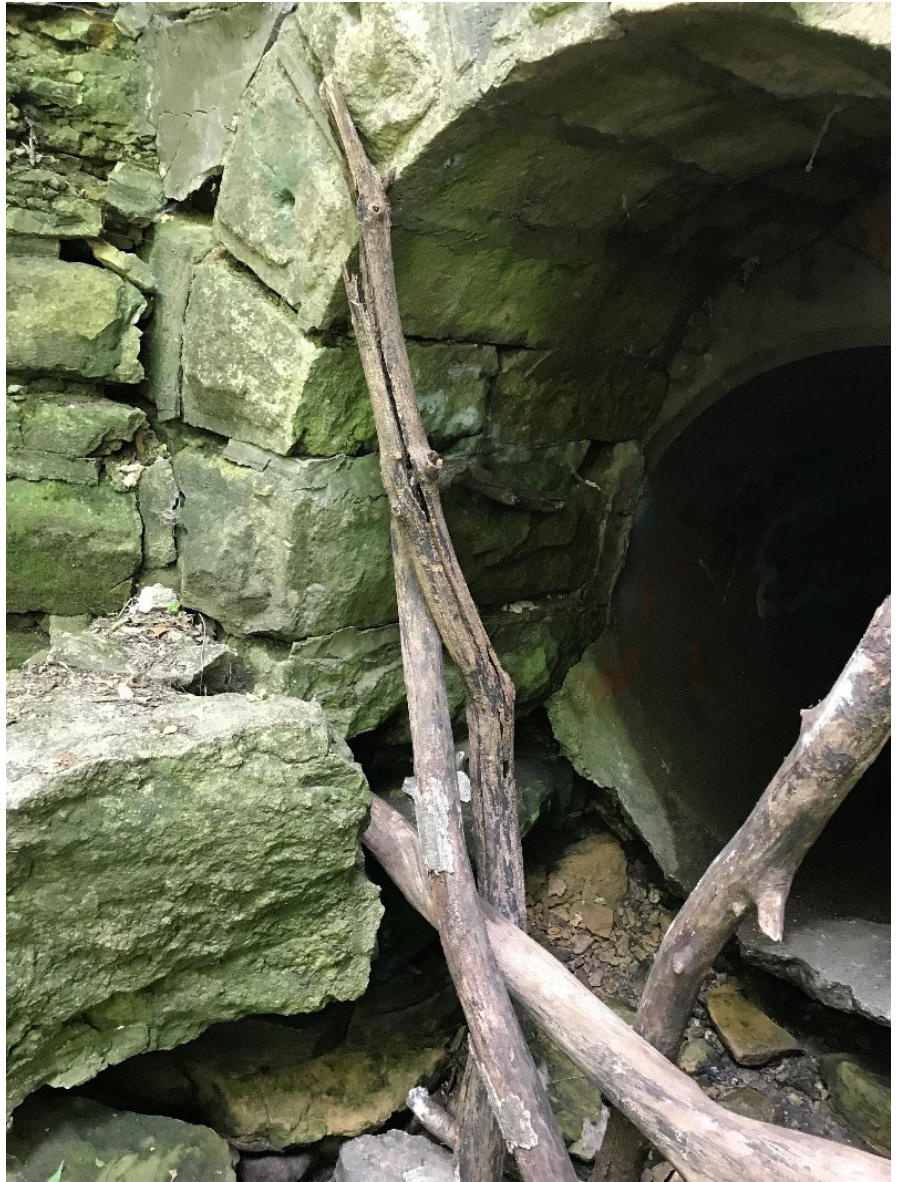
The arch has two primary threats. The failing physical integrity of the weathering sandstone and the undercutting and settling of the base layer of sand, stone and earth.

*Figure 8: Undercutting of the arch at left and 2-3' stone construction depth to the intact concrete culvert that conveys stormwater under the bike path.*

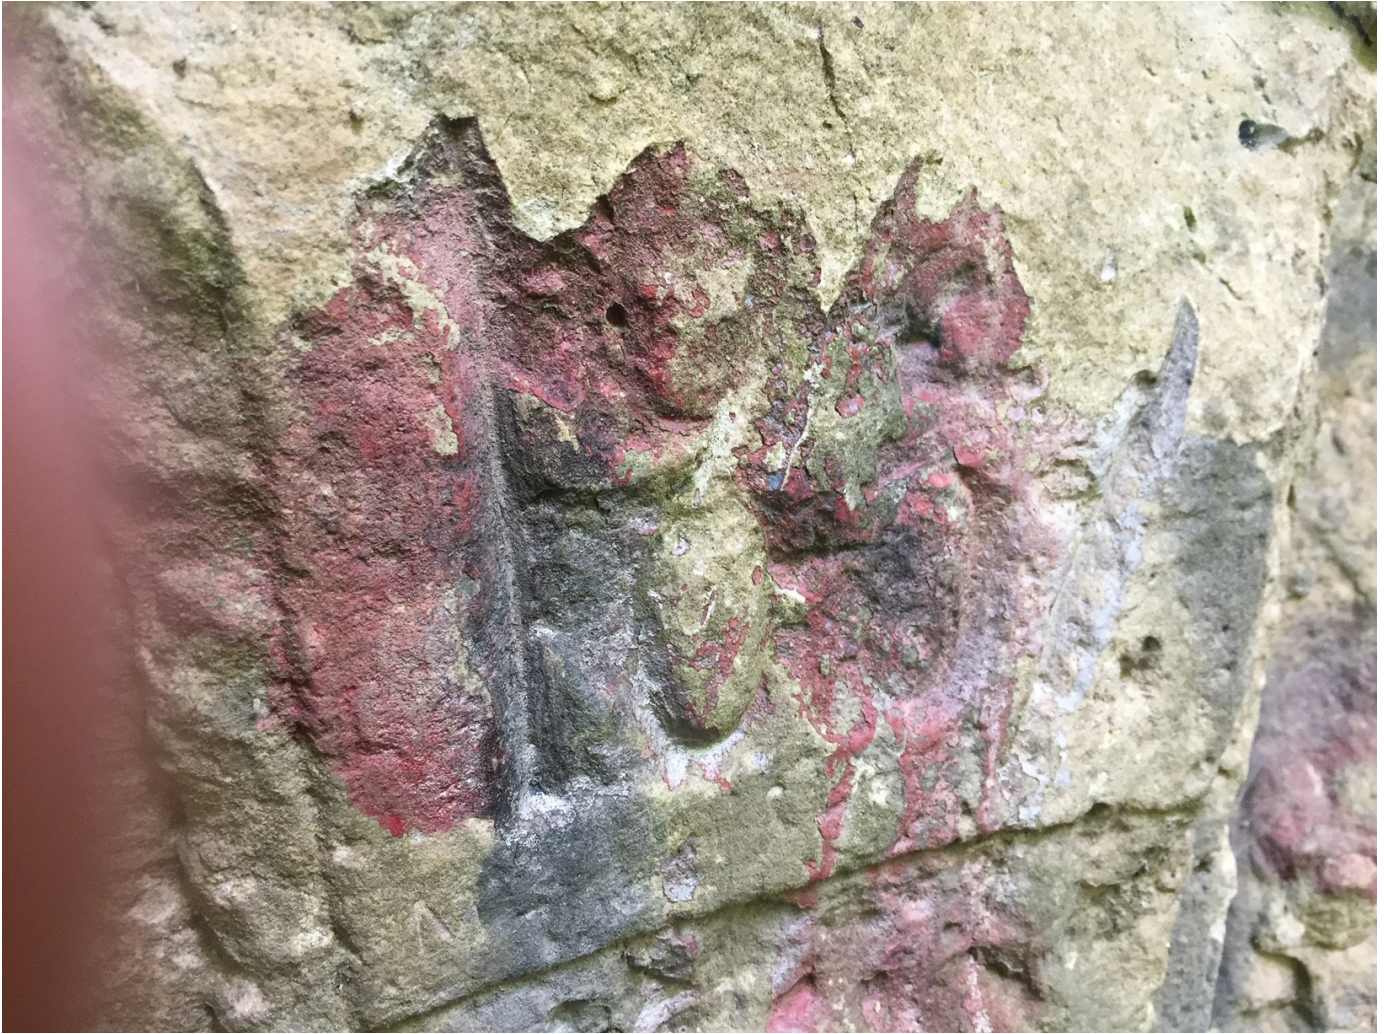
*Figure 9: Defaced keystone needs to be deciphered.*

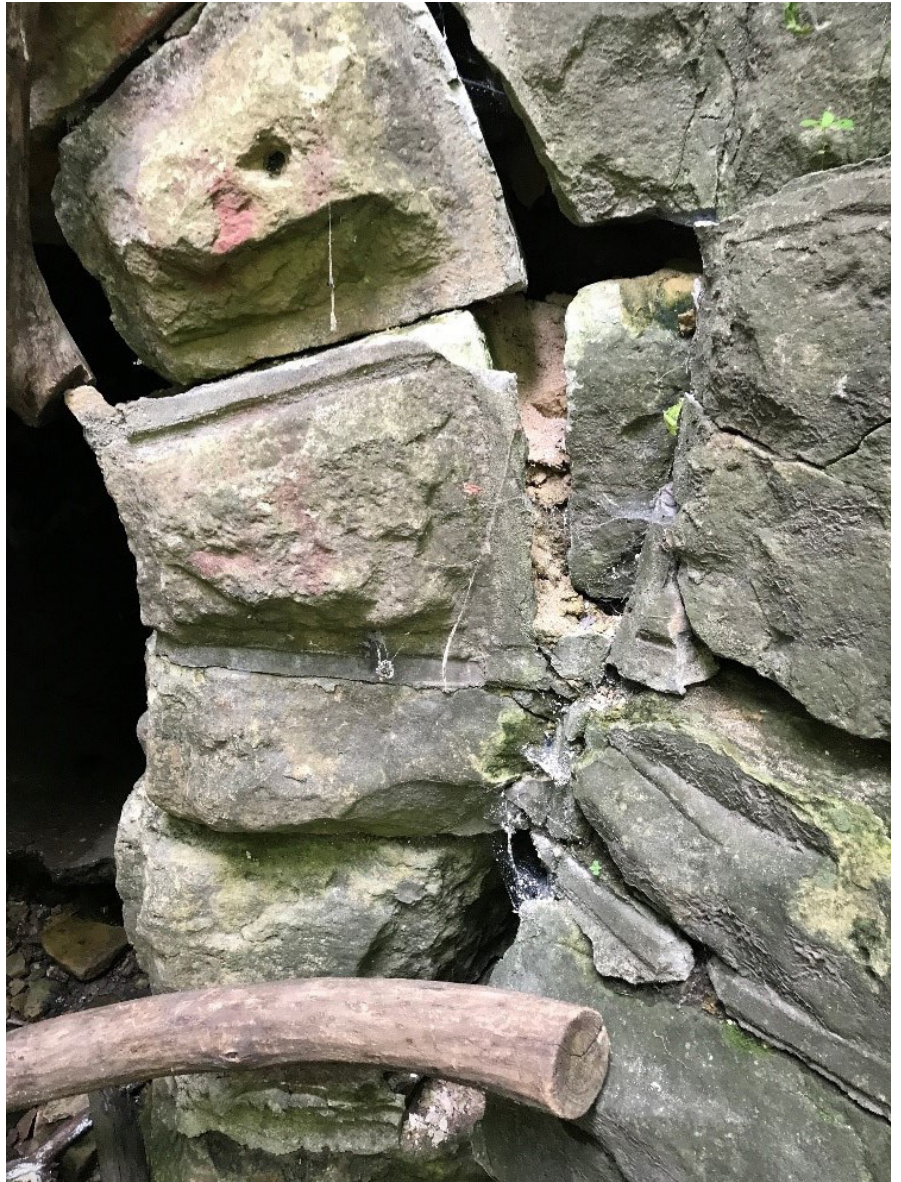
*Figure 10: Degradation of the sandstone at the wing walls is most advanced at the face.*

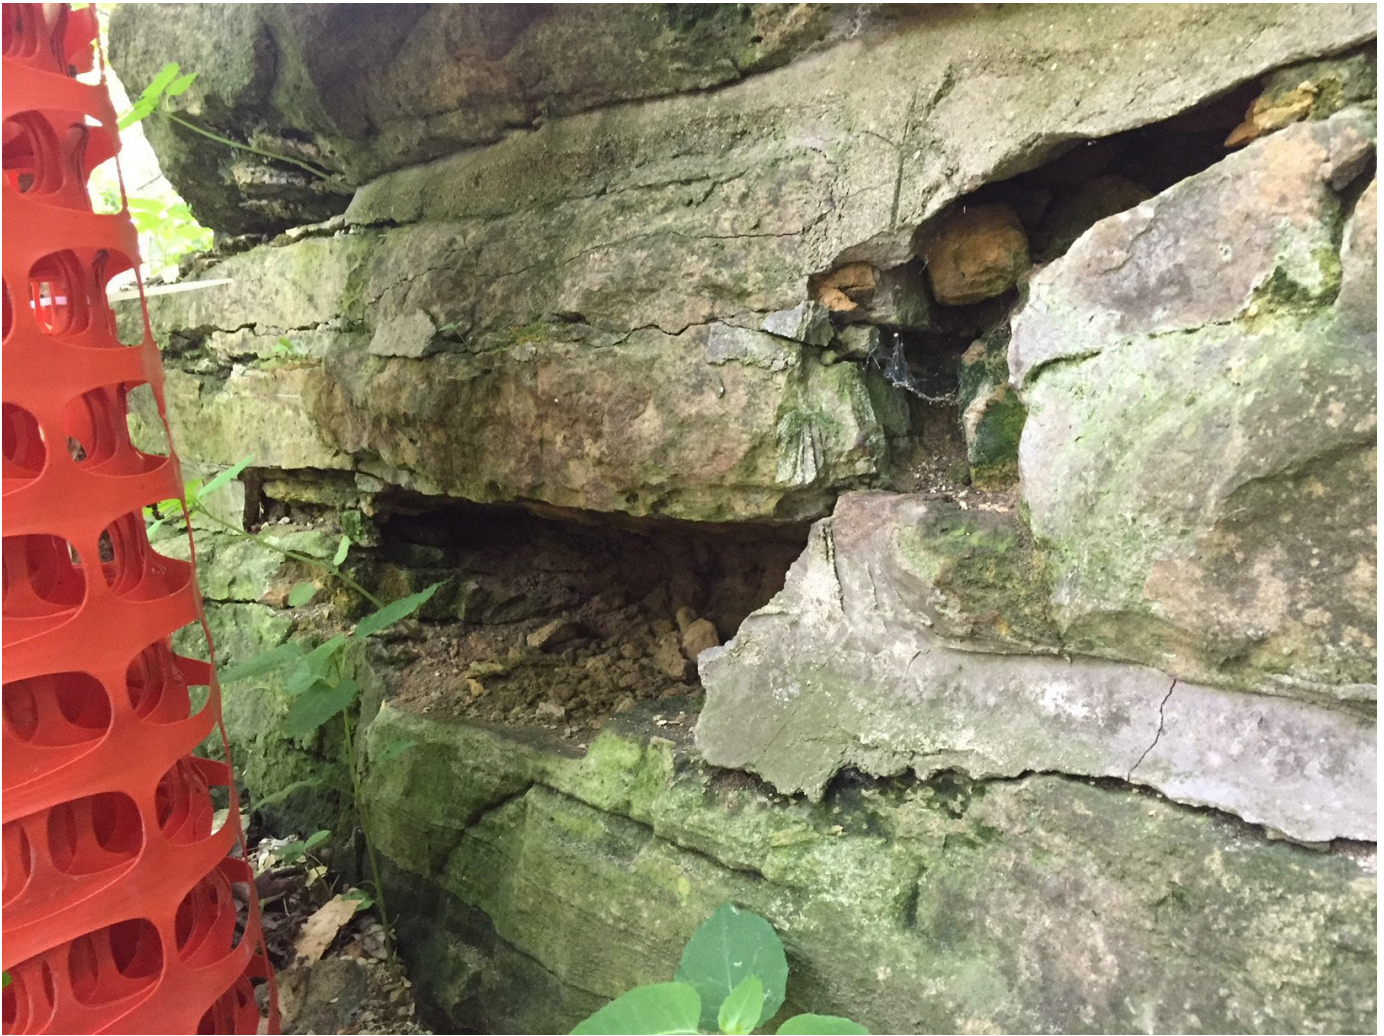
*Figure 11: Degradation of the sandstone at the wing walls is most advanced at the face.*

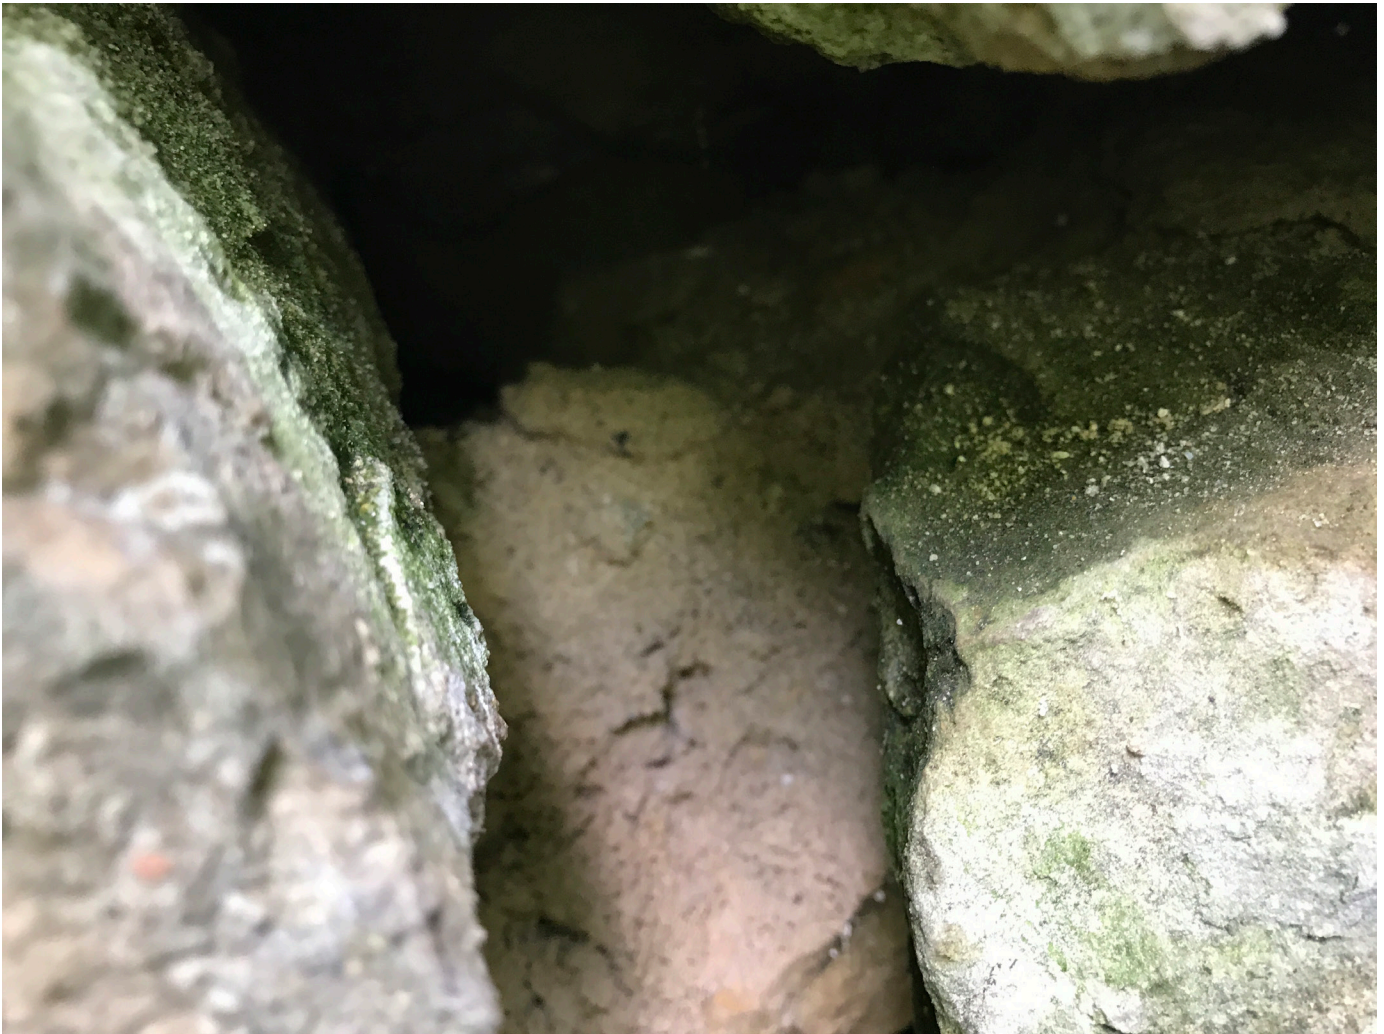
*Figure 12: Degradation of the arch stones deeper in the wall is visible from the open joints where the arch has come out of alignment due to settling at the base at the right.*
