WETLAND DELINEATION REPORT

JAMES MADISON PARK

PROJECT #: 18-101

MAY 25, 2018

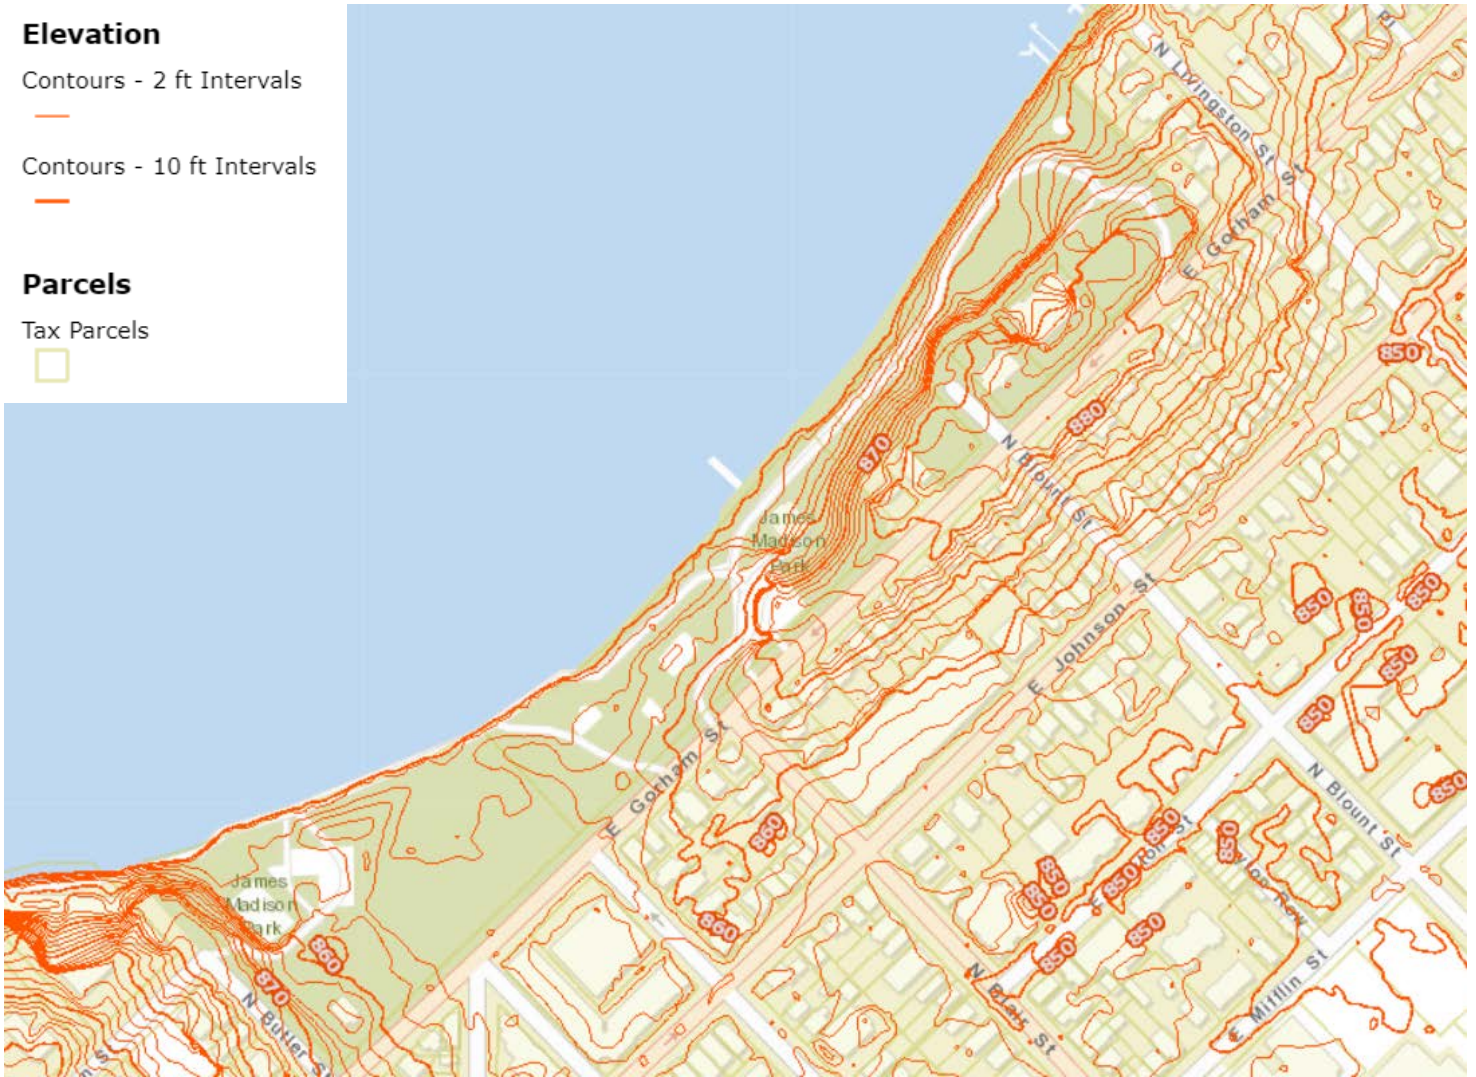
FIGURE 2. TOPOGRAPHIC MAP

The topographic map (**FIGURE 2**) shows that the southwest part of the park is relatively flat, whereas the northeast part of the park is quite steep, with the slope dropping sharply down to Lake Mendota. The slope ranges from 2% at its flattest, to 6% in the middle portion of the park, to approximately 20% in the northeast. The shoreline itself had a very steep slope, about 20% in the northeast half of the park, where it was heavily armored with 2-foot diameter boulders. Except for a small area around the beach and another small area at the southwest end of the park, the remainder of the shoreline consisted of a concrete wall revetment.

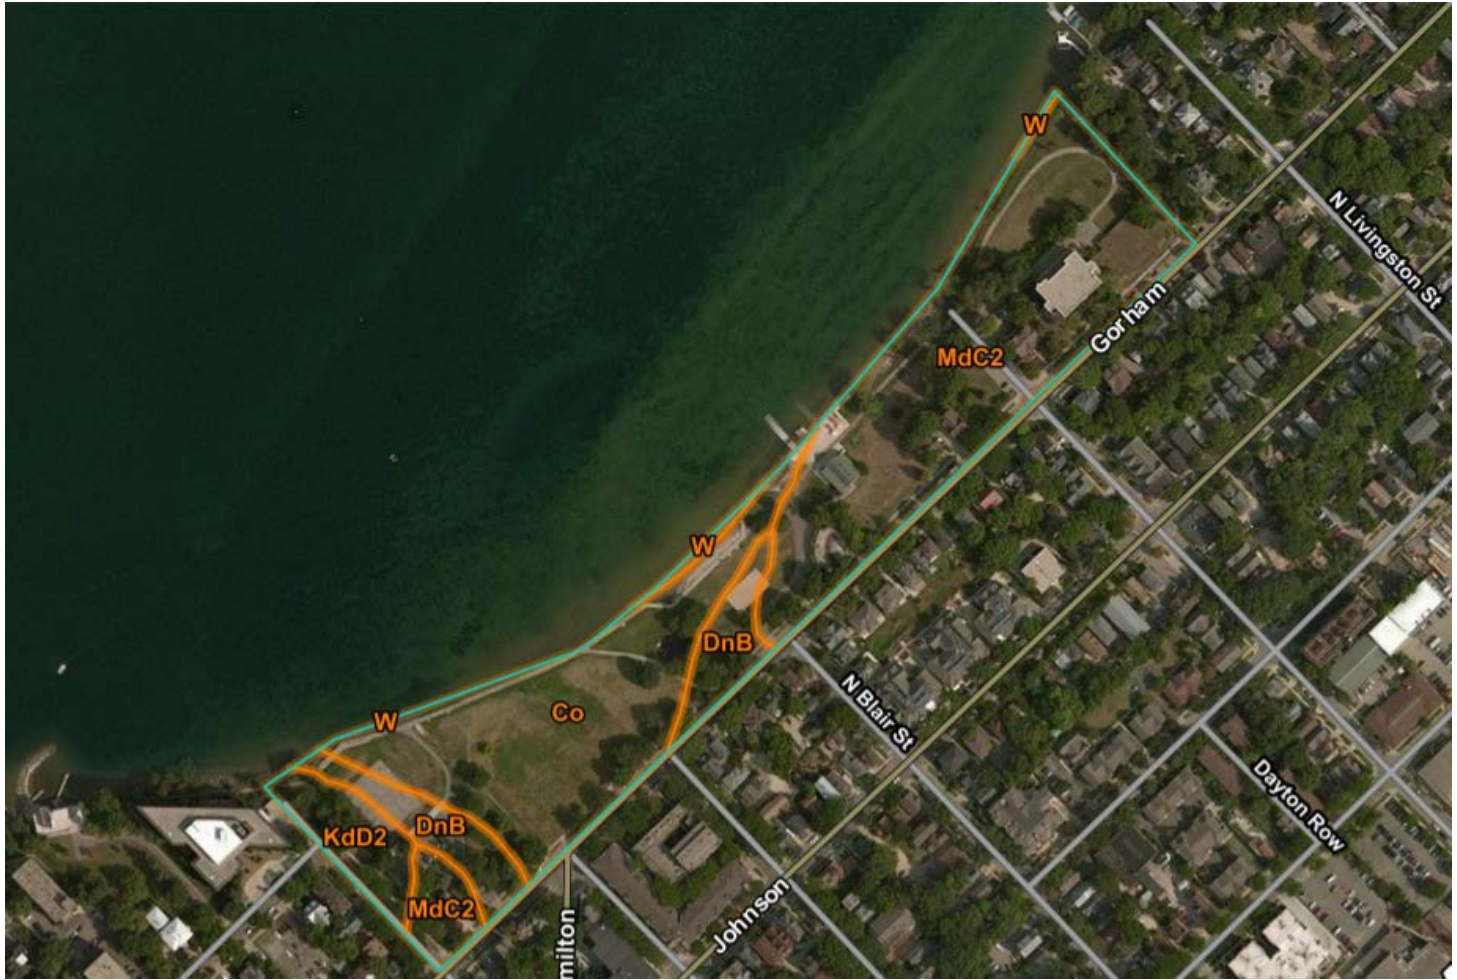
FIGURE 3. SOIL SURVEY MAP

The soil survey map show one hydric soil type in the project area (**FIGURE 3**)—Colwood silt loam. All of the soil types occurring on the property are listed in **Table 2**.

The Wisconsin Wetland Inventory identifies no wetlands within the project area (**FIGURE 4**). The Colwood silt loam is shown as a wetland indicator soil in the southeast part of the property.

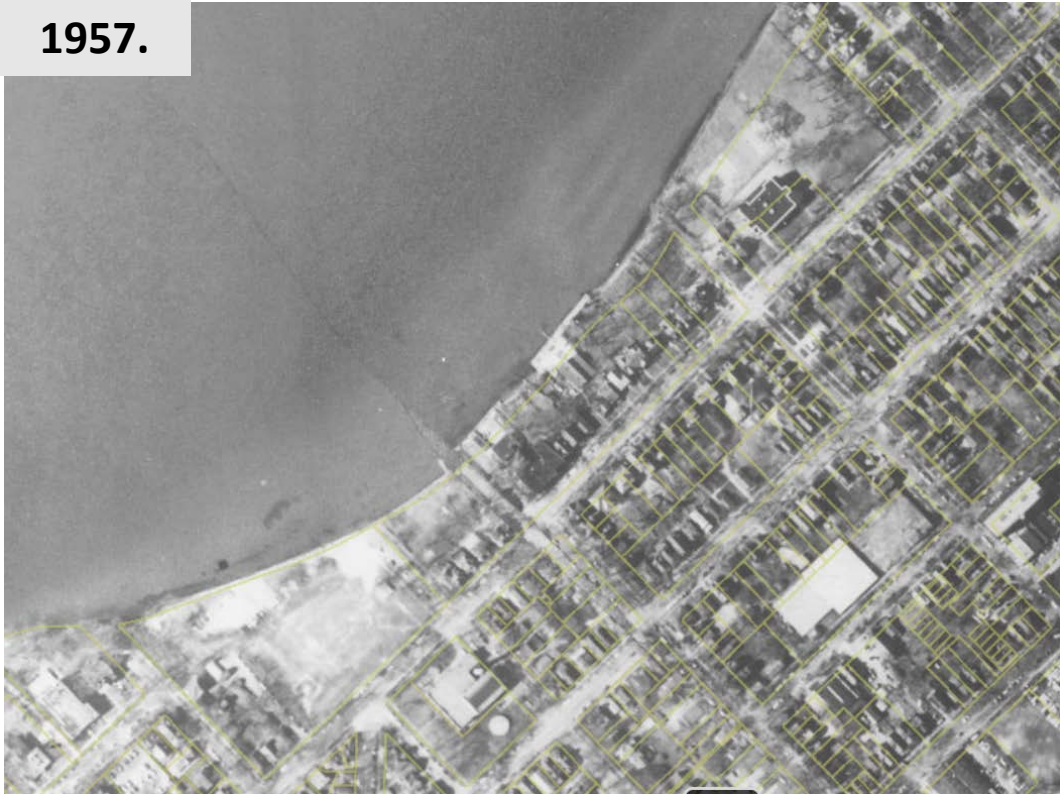
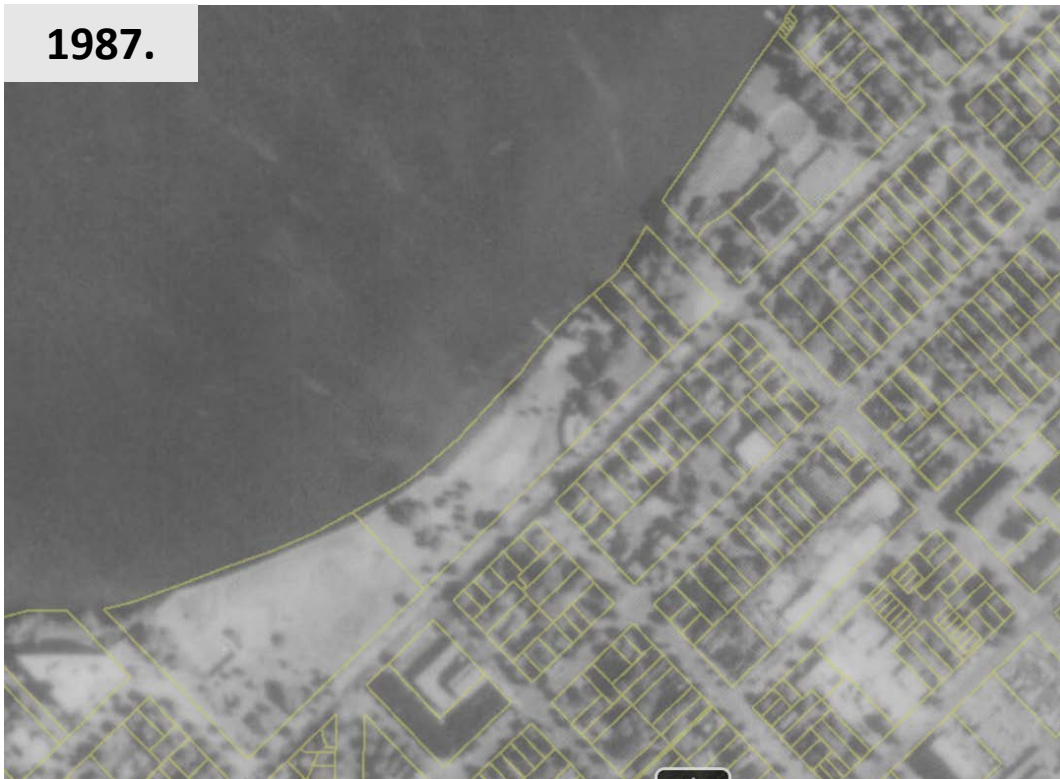
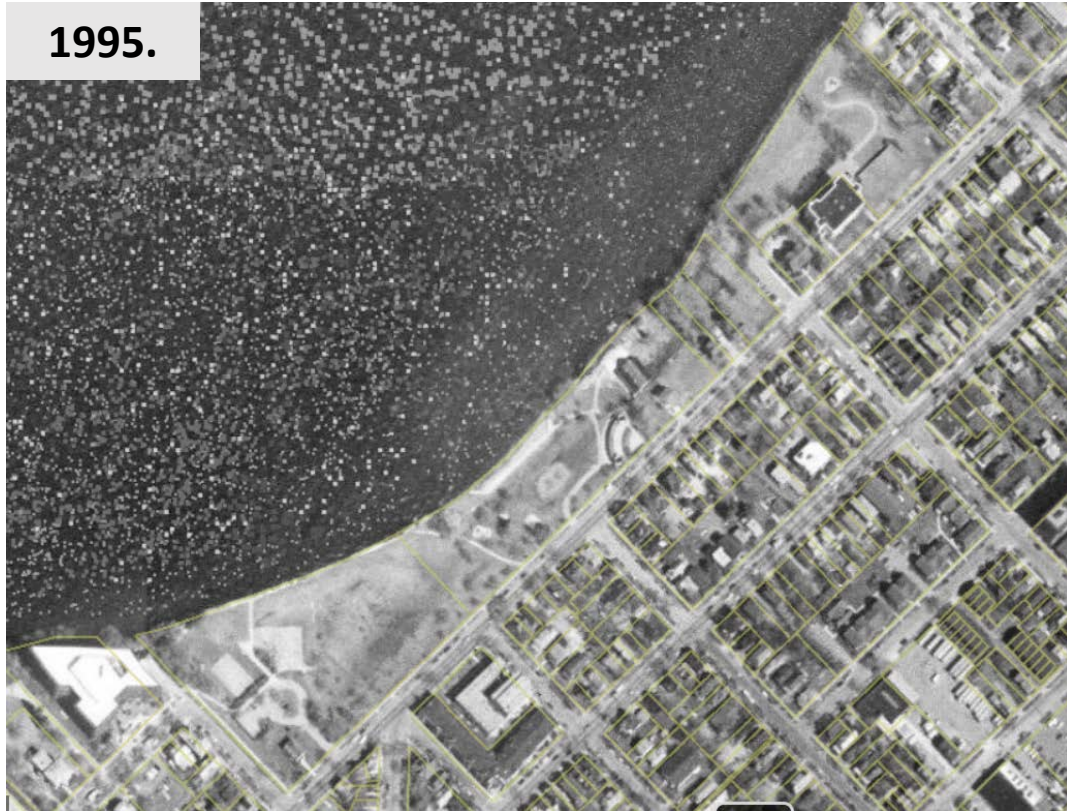
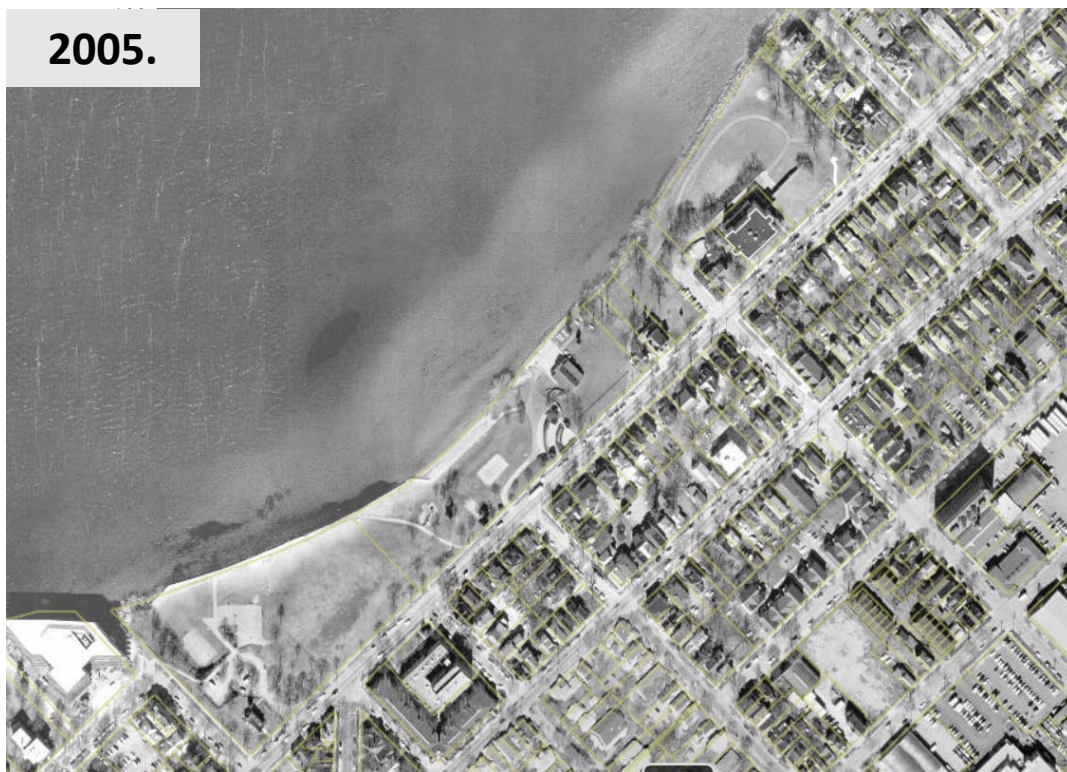
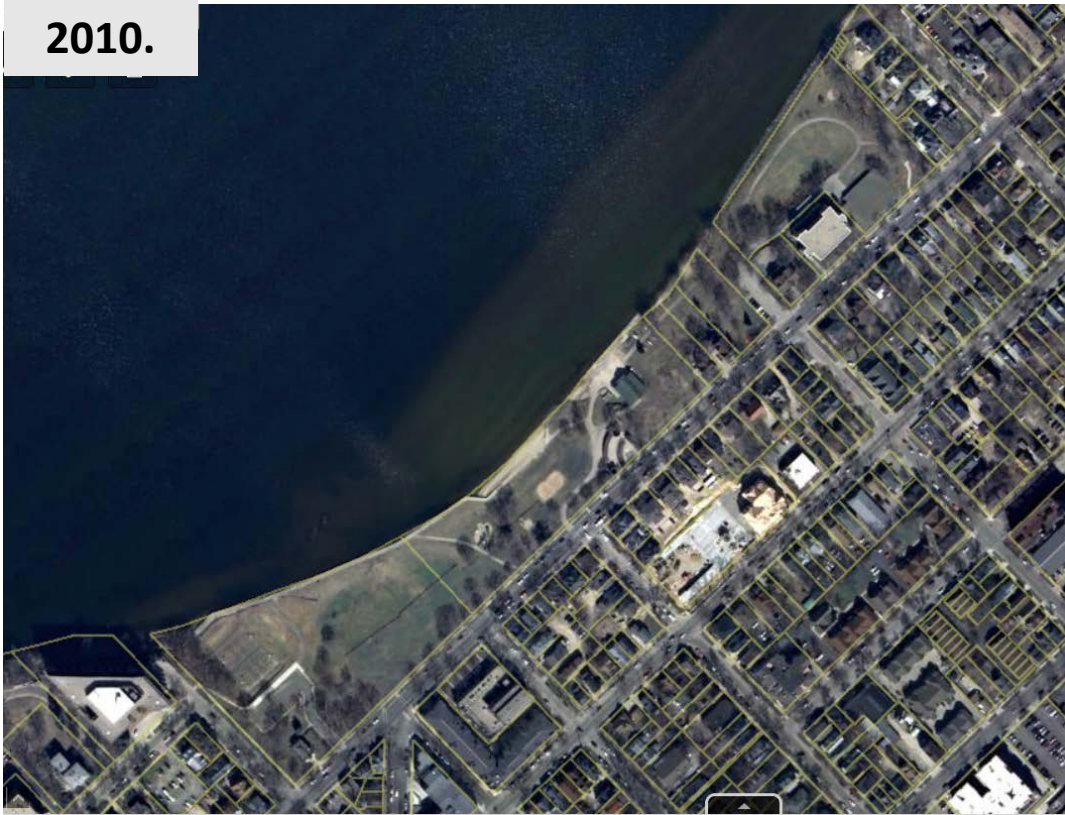
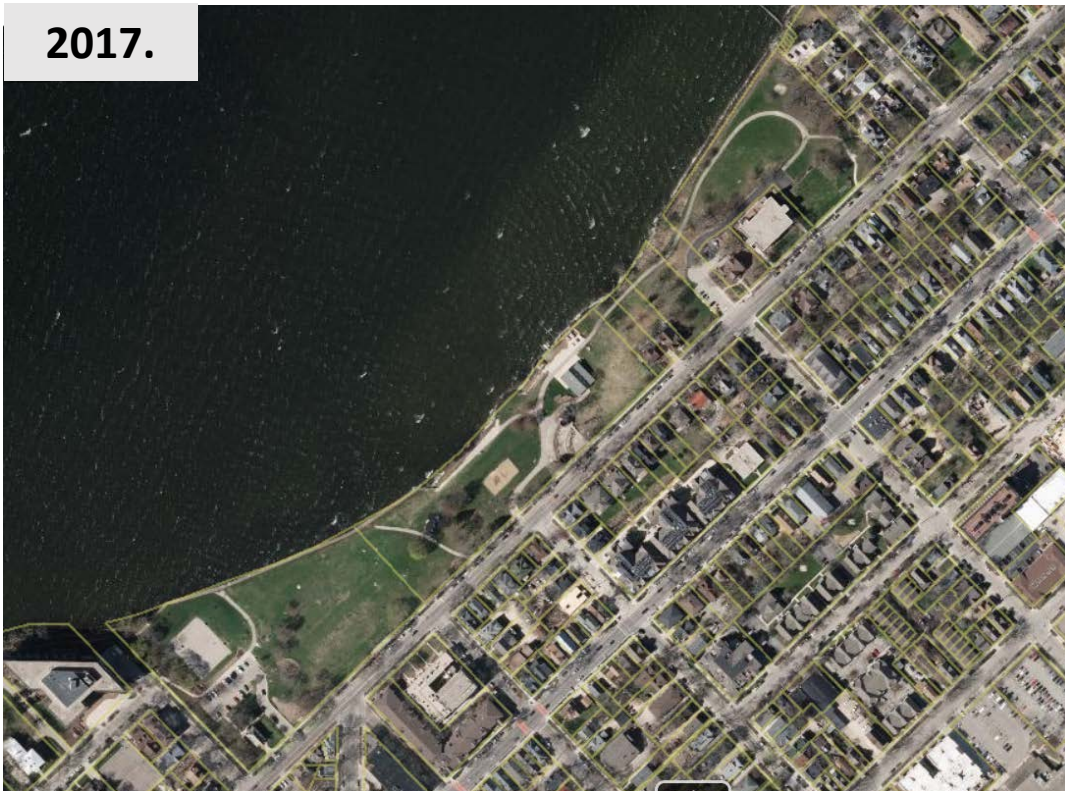
FIGURE 5. HISTORIC AERIAL PHOTOS

Historic aerial photographs show that the original extent of the park is only the southwest corner, and the remainder of the park consisted of single family homes that lined the lakeshore (**FIGURE 5**). By 1995, however, most of the houses had been razed and the park became the size it is today. There was no indication of any kind of wetland occurring within the park boundaries in any of the aerial photographs.

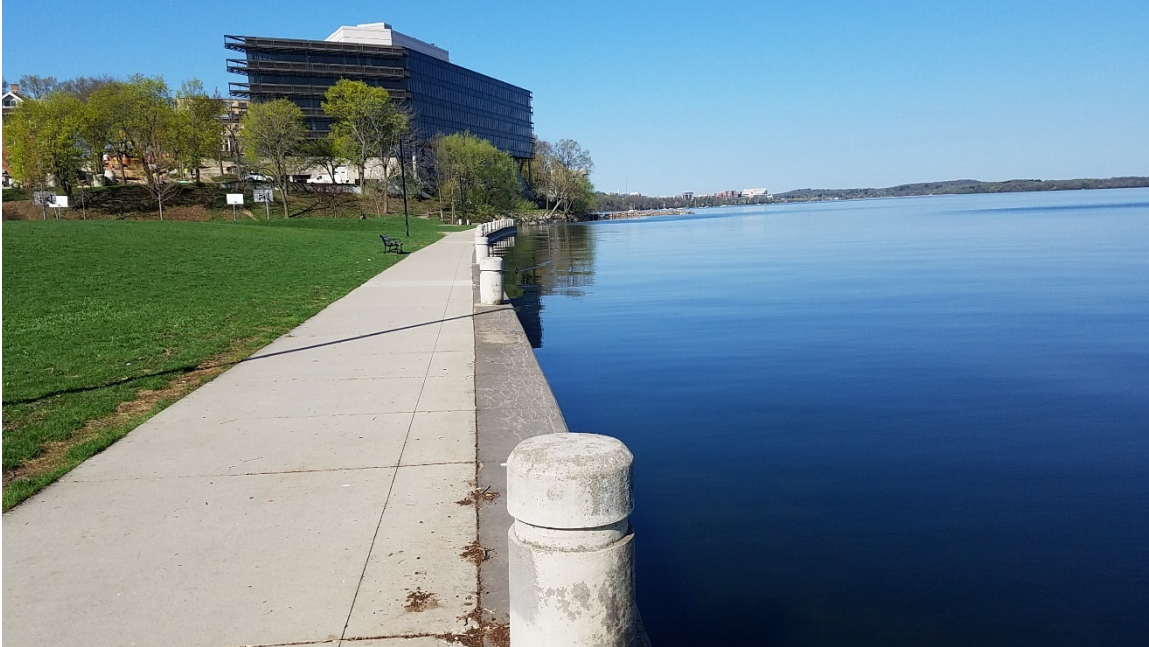
The majority of the shoreline is lined with a concrete wall.

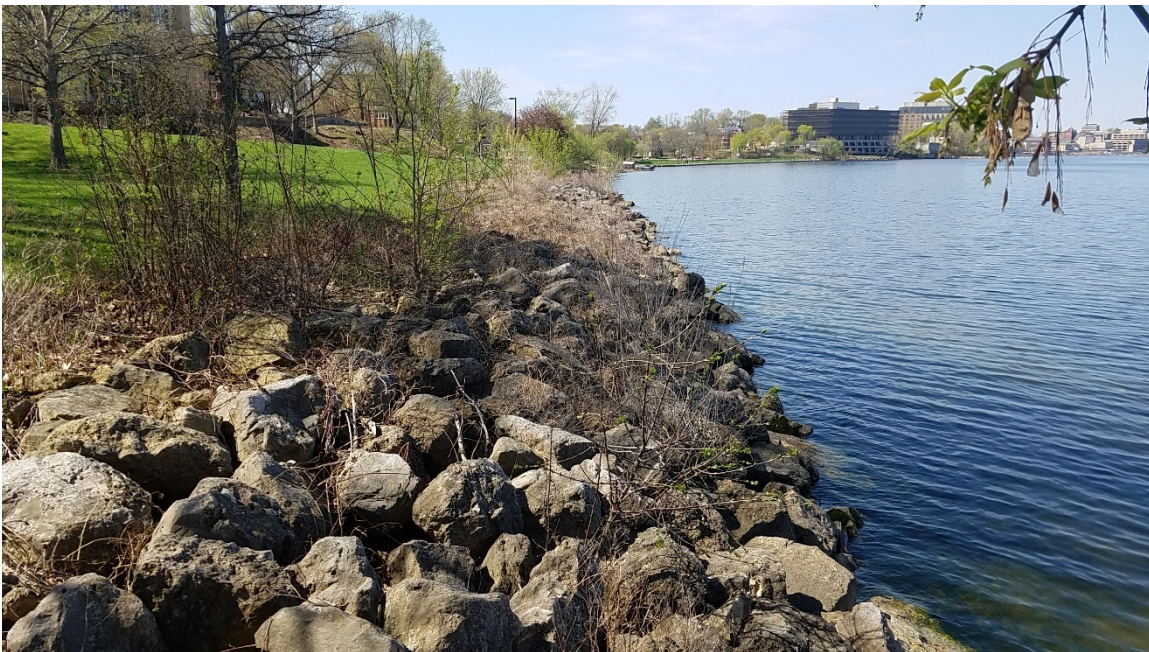
The northeastern half of the shoreline is lined with large boulders on a steep slope.

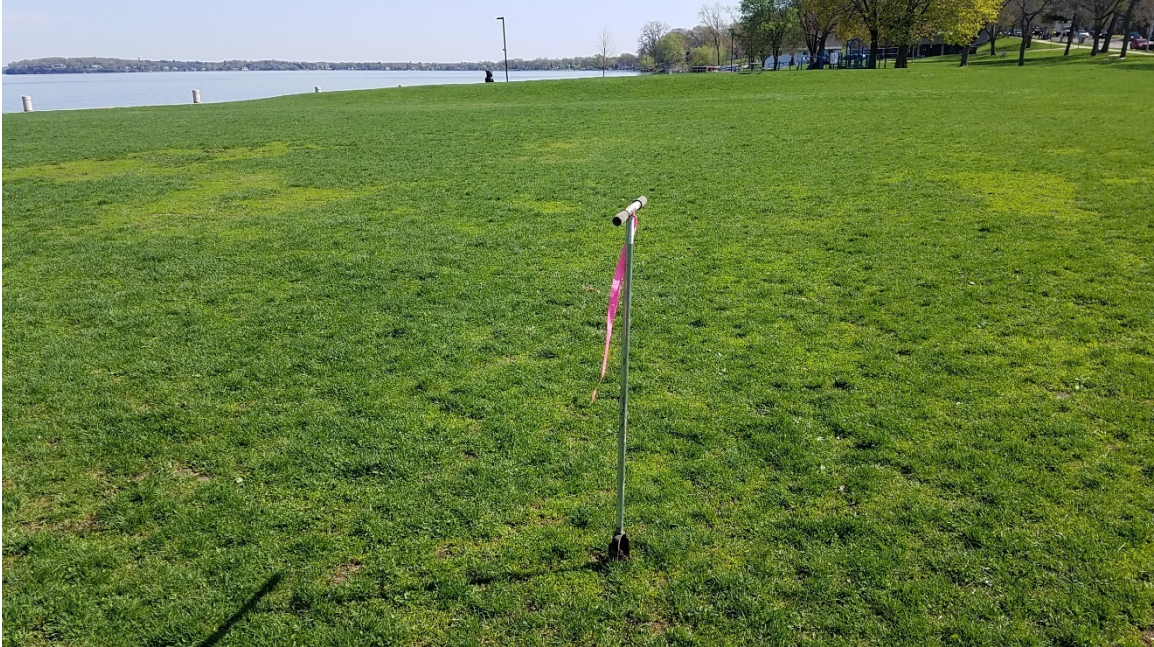
The adjacent upland was a mowed lawn area that occurred in an area mapped as Colwood silt loam. The dominant vegetation was Kentucky bluegrass. Soils were non-hydric. They consisted of a layer of topsoil over what appeared to be fill material because small fragments of trash were visible in the soil profile. A restrictive layer of rocky gravel fill was found at 13 inches below the ground surface. The only hydrology indicator was Geomorphic Position, due to the slight saddle in the landscape, though the ground sloped towards the lake.

The sample point taken in the Colwood hydric soil is mowed lawn.

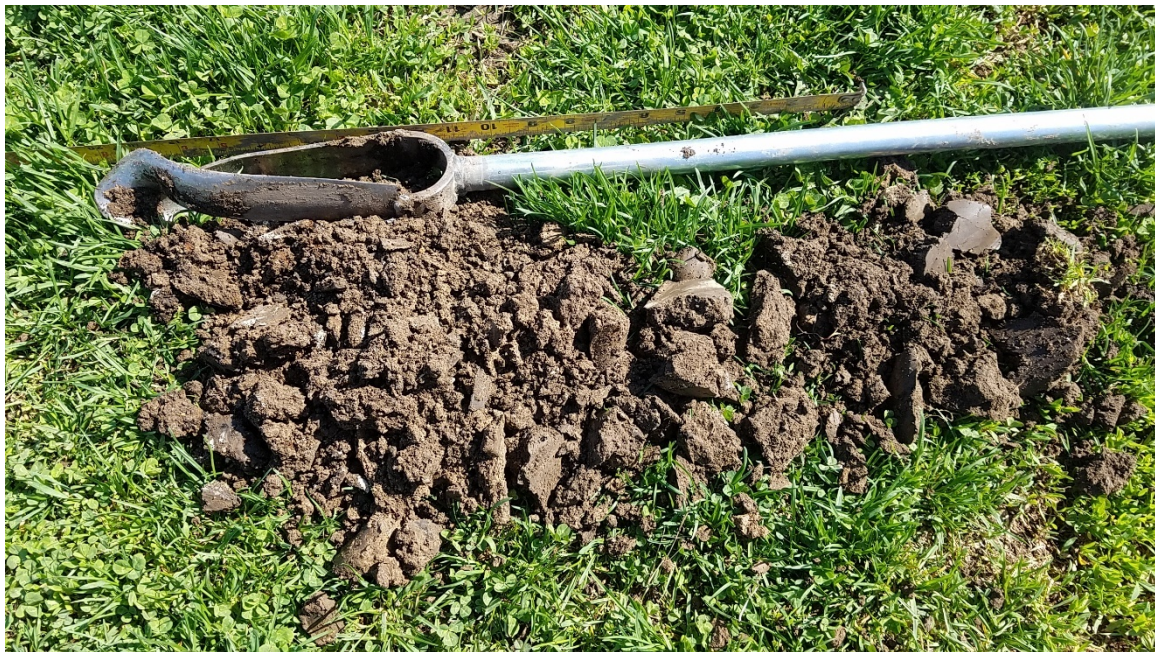
The soils at this sample point appears to be fill material.

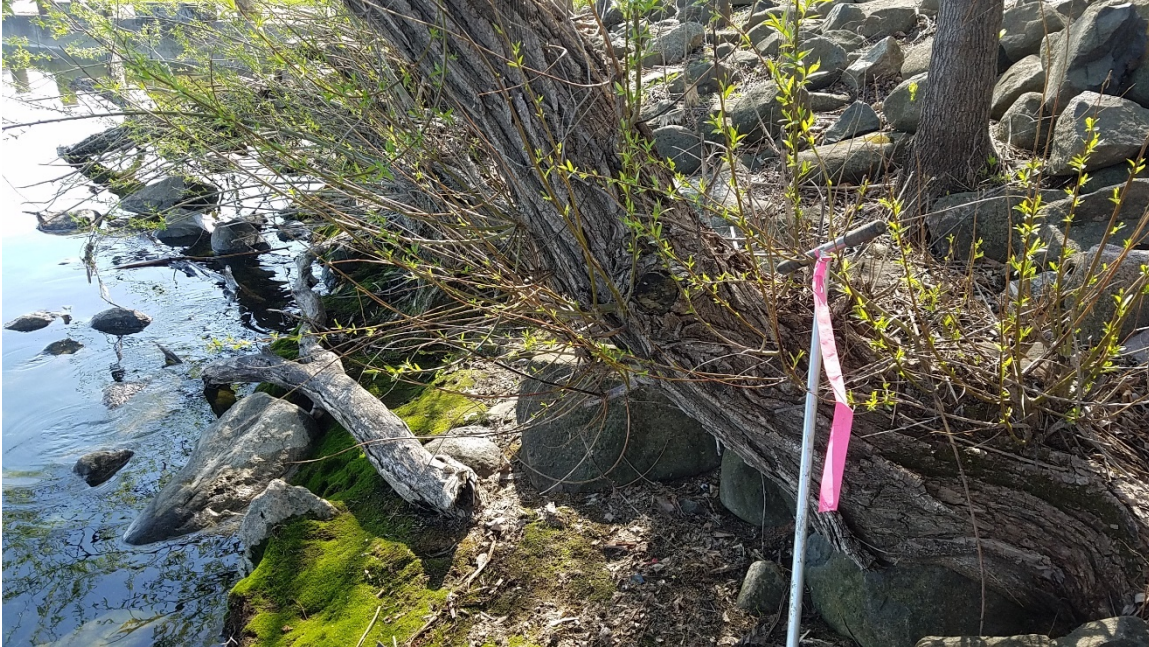
The wetland area was a scrub-shrub wetland that occurred along the lakeshore at the southwest side of the property. The dominant vegetation was black willow. The soils were problematic because there was only a thin layer of soil over the top of the riprap. They met the test criteria for S7-Dark Surface, which is a 4-inch thick dark surface layer in sandy soil types. The hydrology indicators were FAC-Neutral Test and Geomorphic Position. The wetland boundary occurred at the toe of slope of the riprap.

The southwest corner of the property has a small wetland along the shoreline.

Chapter NR 151-Runoff Management defines buffer areas for different wetland types to protect them from nutrient enrichment from storm water runoff. Final authority on the NR 151 protective areas rests with the DNR, but it is likely that this area would have a protective buffer of 50 feet.

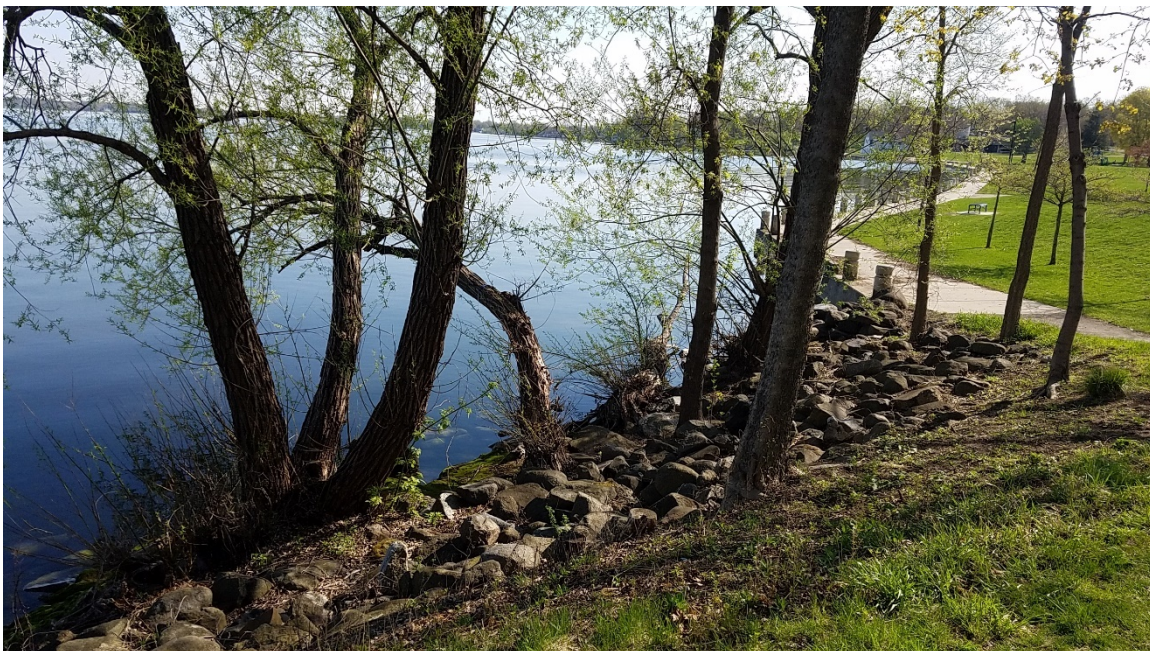
The adjacent upland area consisted of riprap on a hillslope that was approximately two feet higher in elevation than the adjacent wetland. The vegetation was dominated by Norway maple, hackberry, Kentucky bluegrass, jewelweed, dandelion, white snakeroot, burdock, and white avens. The soils lacked hydric indicators, consisting of an inch of soil over solid rock/gravel riprap, and hydrology indicators were also lacking.

The wetland is located at the water's edge, with rock riprap occurring above the wetland boundary.

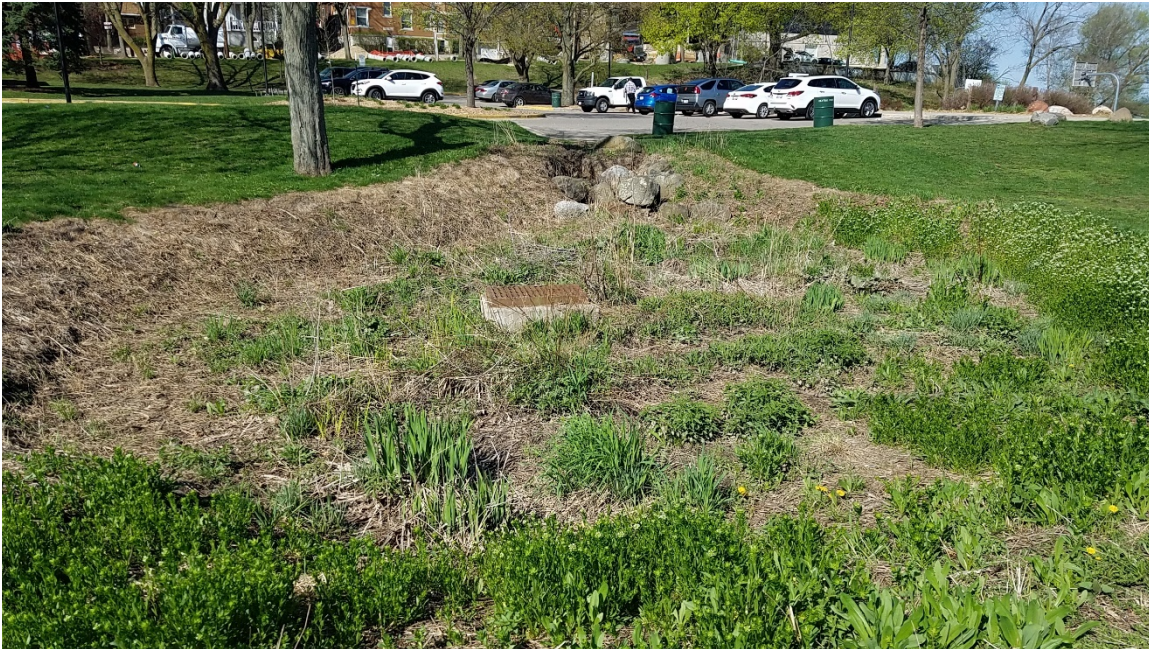
The wetland area was a constructed detention basin planted with wetland plant species. It had a sewer grate outlet structure set at approximately one foot above the bottom of

the basin. The dominant vegetation was Virginia ryegrass, iris, burdock, and golden alexanders. The soils met the criteria for F6-Redox Dark Surface, with redoximorphic features starting at 6 inches below the ground surface. A solid gravel layer was encountered at 17 inches. The hydrology indicators were Saturation, Sediment Deposits, FAC-Neutral Test, and Geomorphic Position. The wetland boundary occurred at the toe of slope of the basin.

A constructed detention basin contains wetland vegetation.

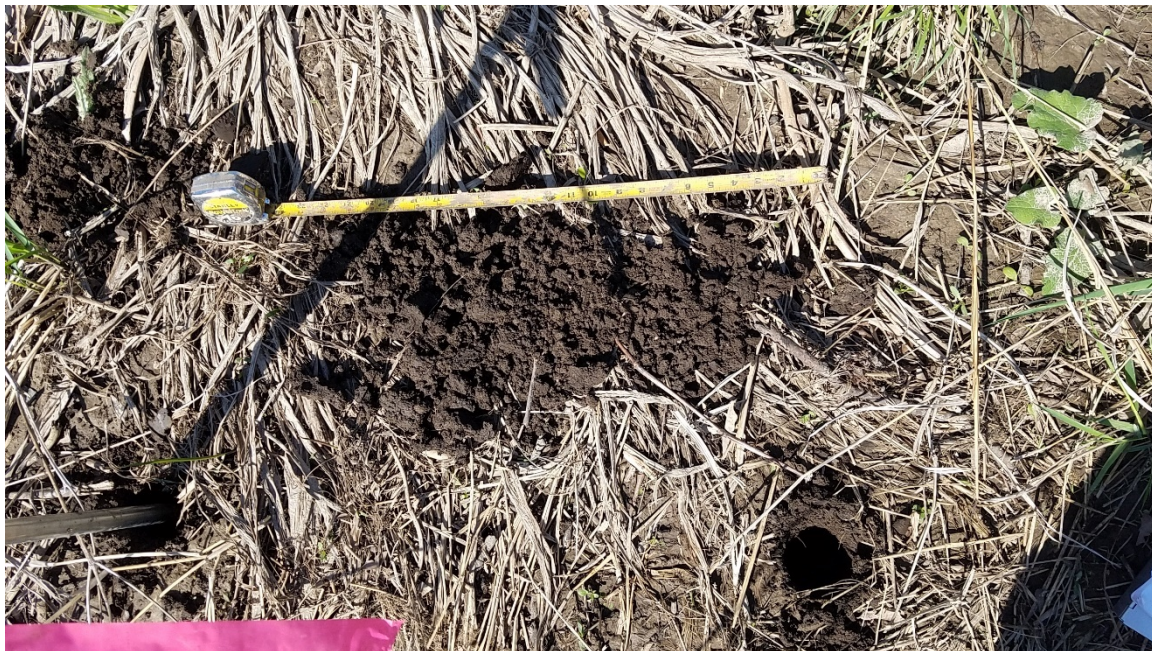
The soils were also hydric within the basin.

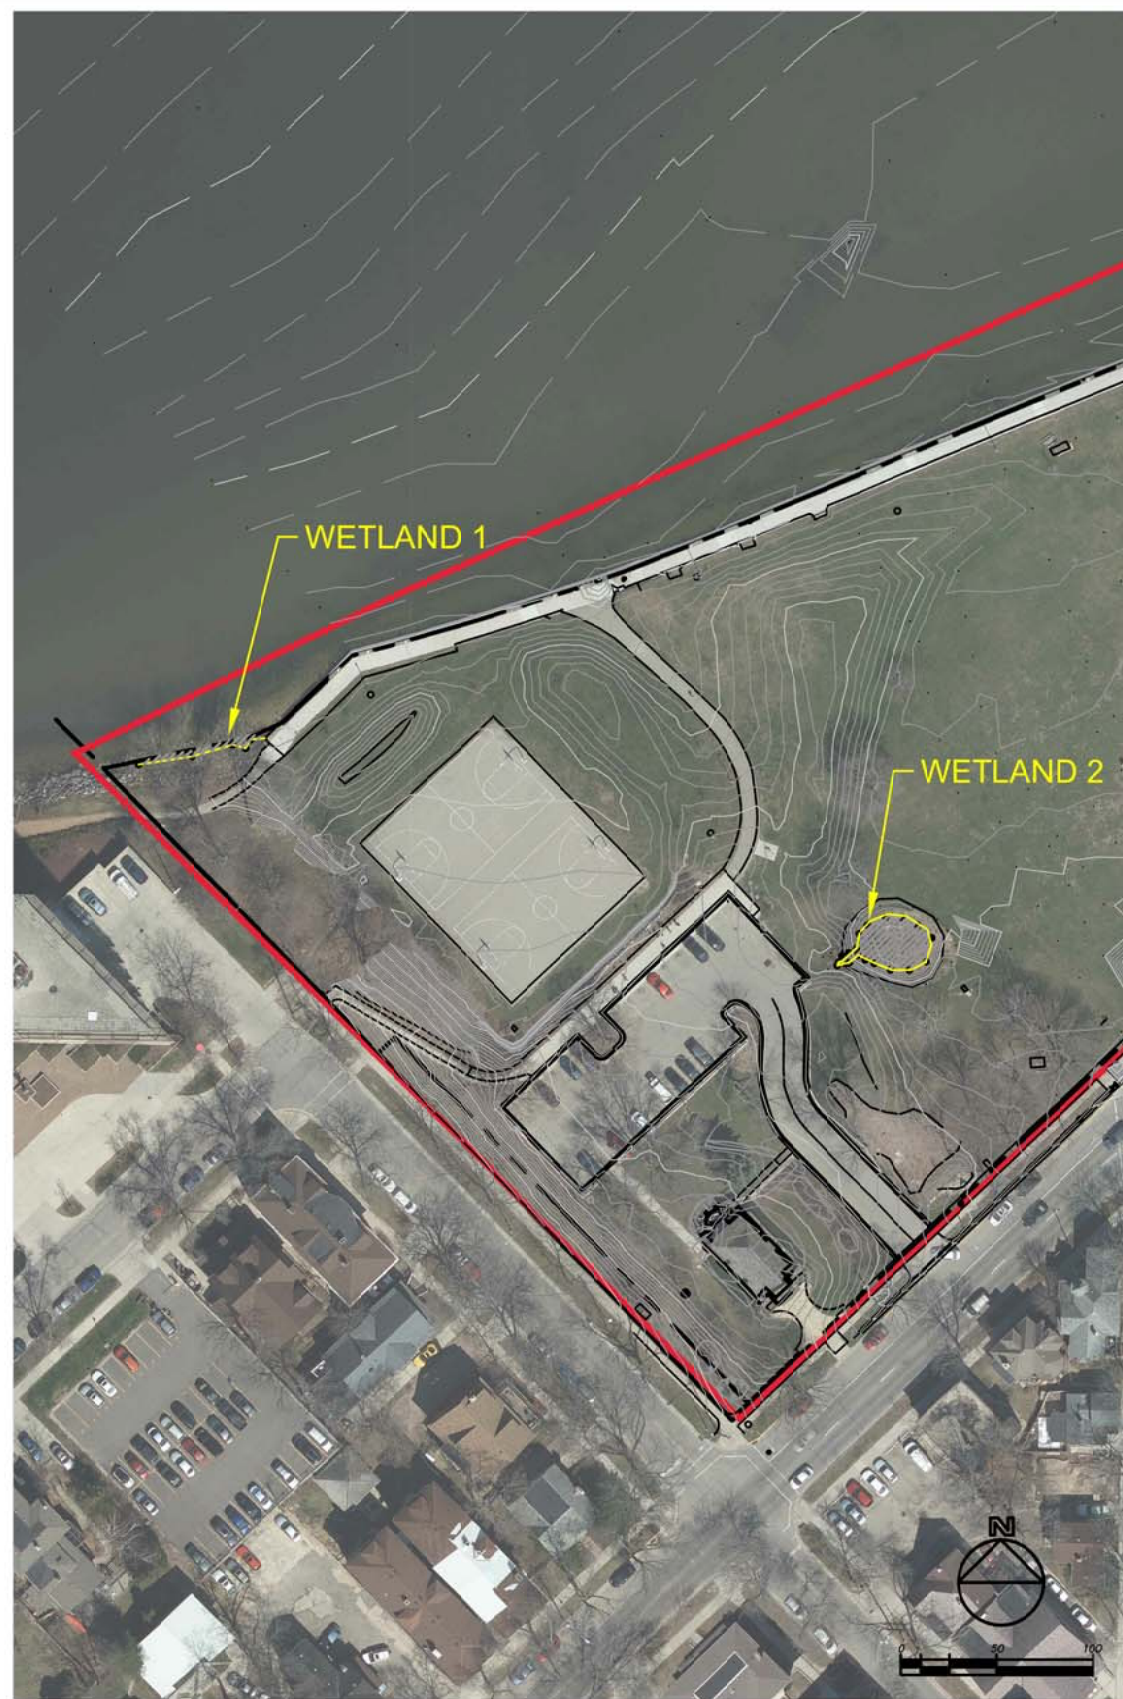
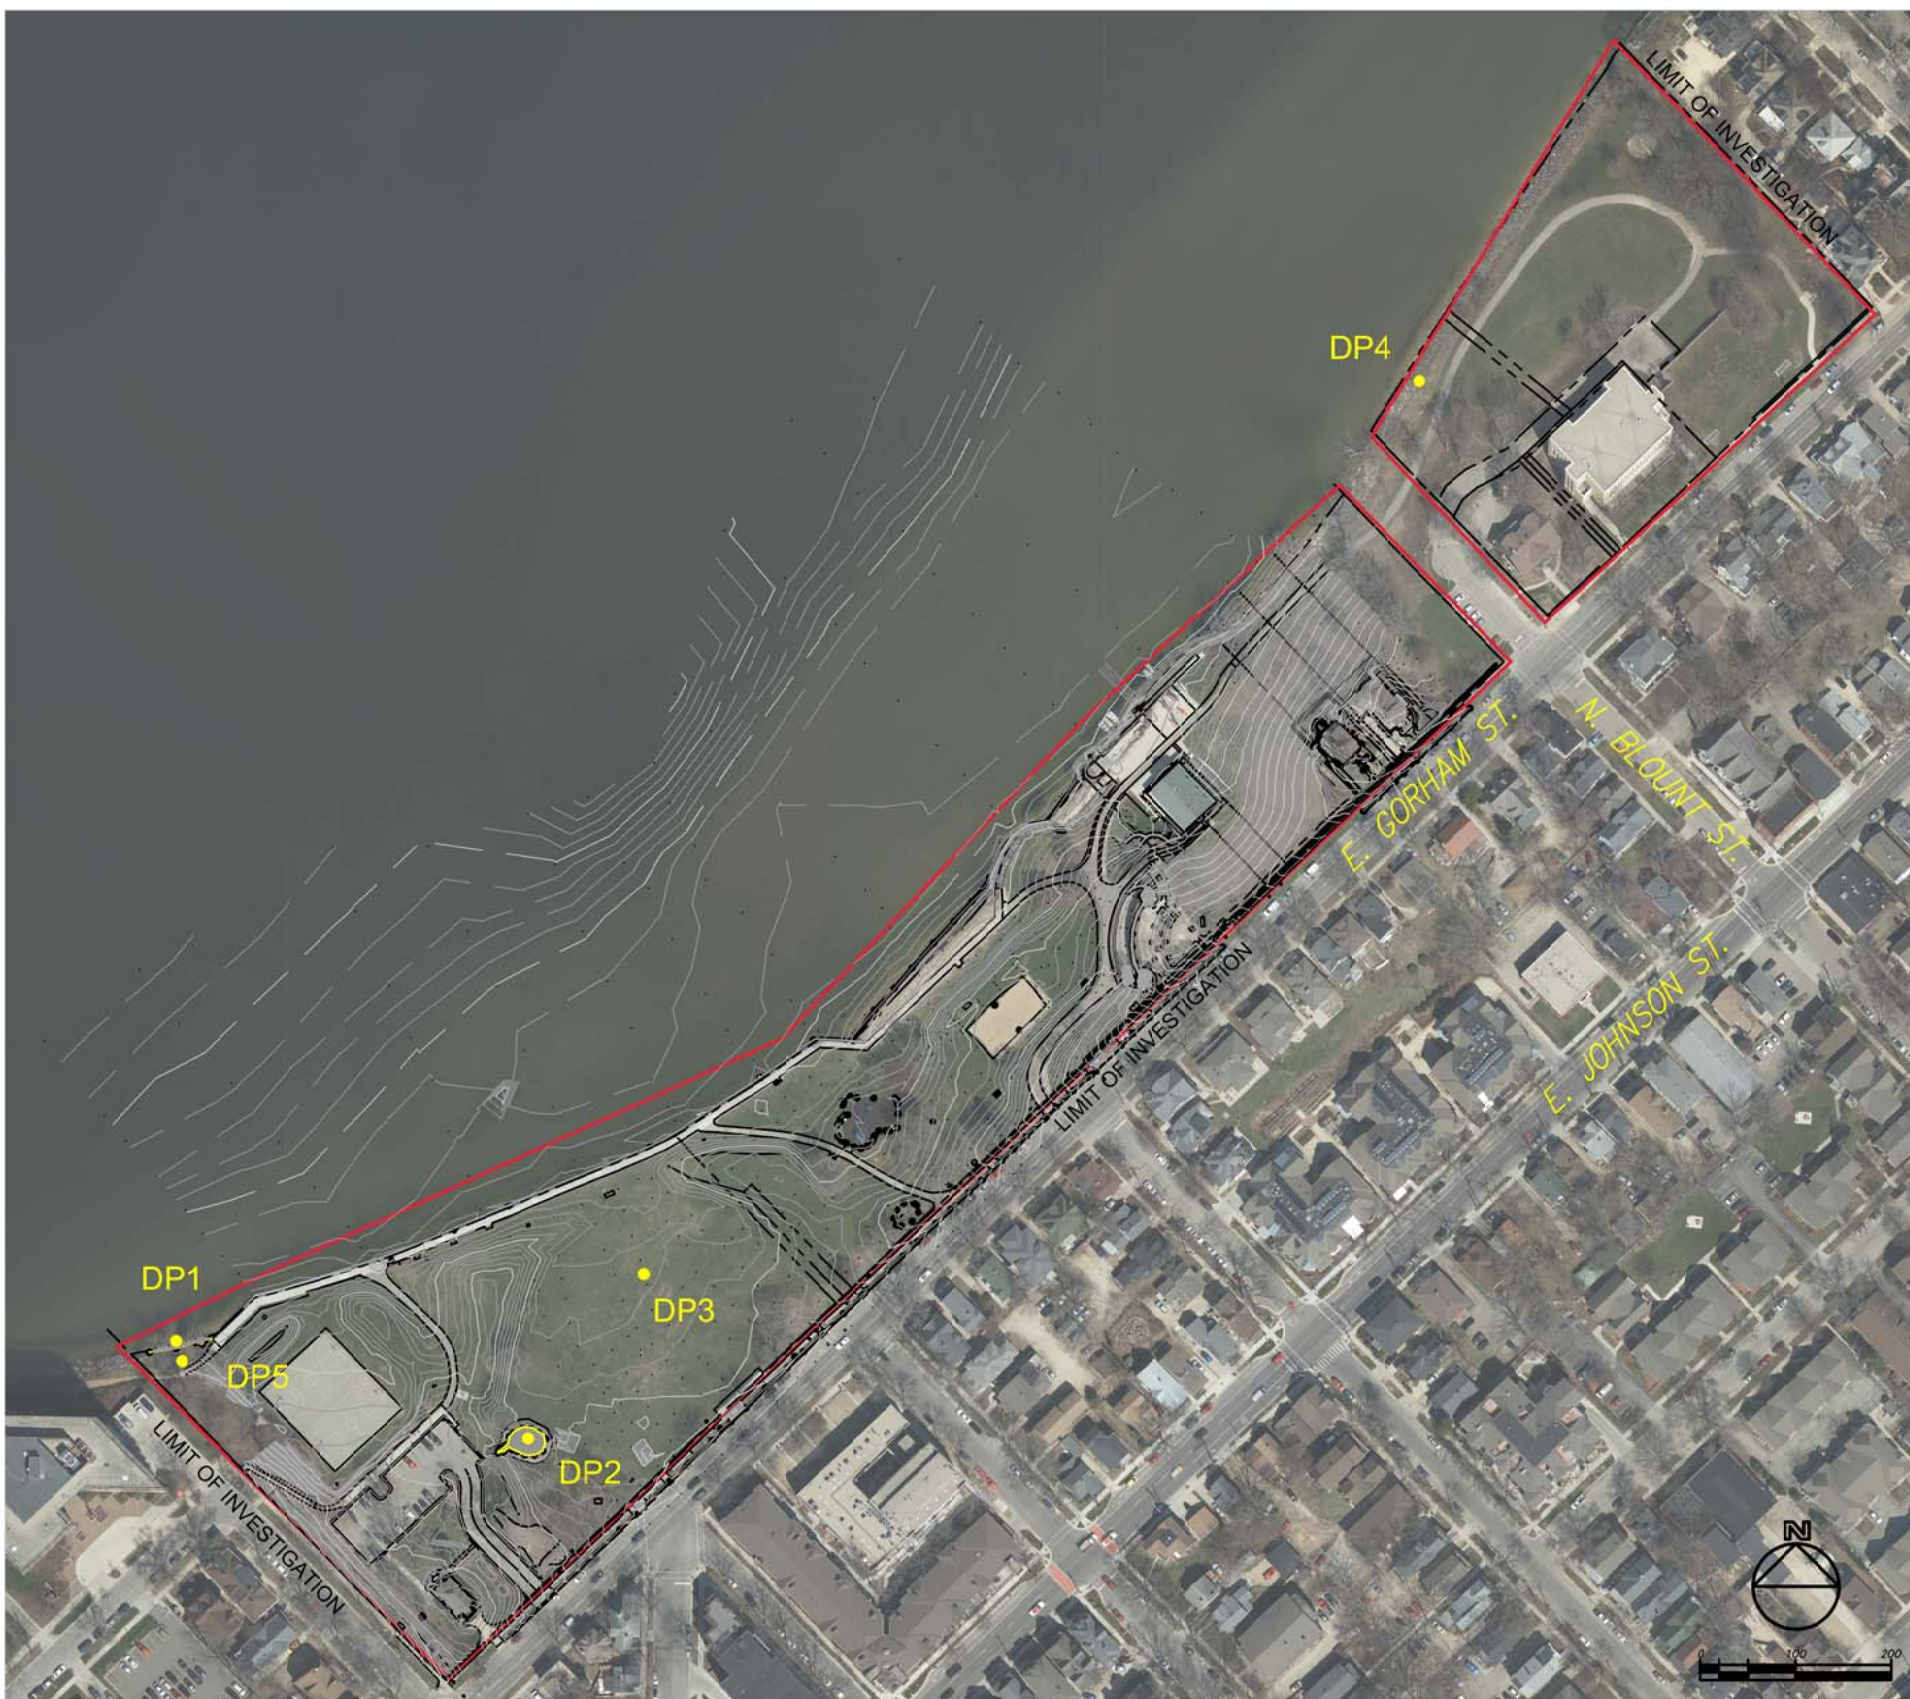
Exhibit
FIGURE 8
 Project 18-101
 Date 05-24-2018
 Drawn by KAS
 Sheet **W1.0**

A total of two wetlands were identified on the property during the field visit. Site photos of the property are included in **FIGURE 6**. The area and wetland boundary that was identified and flagged for the project are shown in **FIGURE 7**. Field data sheets are included in **FIGURE 8**. A description of the wetland areas follows.

WETLAND BOUNDARY MAP
JAMES MADISON PARK
 614 E. GORHAM ST, MADISON WI
