## 2. Physical Condition

Institution | City of Madison  
 Building Name | Fairchild Building  
 Building Number | 120 South Fairchild Street

### PHYSICAL CONDITION ASSESSMENT

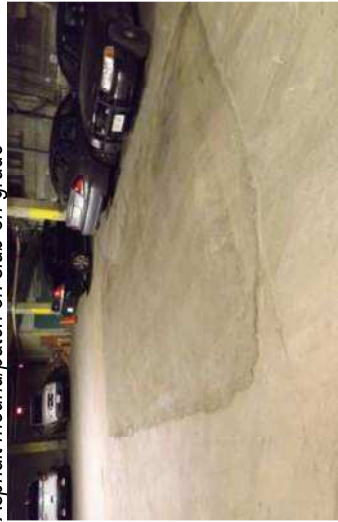
Figure 3

<b>A40</b>	<b>Slabs-on-Grade</b>					
		Existing drawings indicate slabs to be 5" thick, but it is unknown if or how these are reinforced.			ii	Included with B10  Slabs display a varying degree of levelness, with some old cracking, likely indicating localized subgrade settlements occurring long ago. They are serviceable for the current use. There is a curious, somewhat mounded asphalt area on the ground floor level, purpose unknown. It was noted column bases at slab-on-grade had a tapered concrete extension, presumably to cover steel base plate extensions. These concrete "covers" display varying extents of cracking and break-out. In vehicle storage areas, it would be prudent to  Figures 3, 4 & 5

Asphalt mound/patch on slab-on-grade

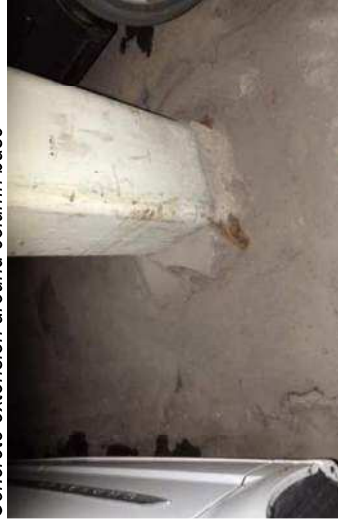
Figure 4

Concrete extension around column base

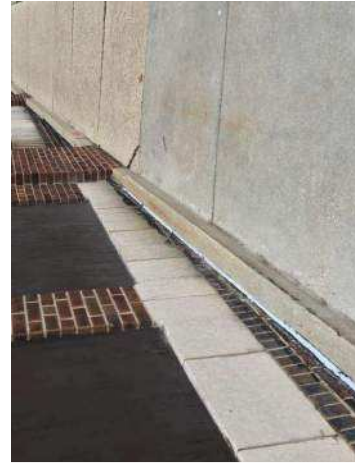
Figure 15

Caulk joint failing at brick and sidewalk

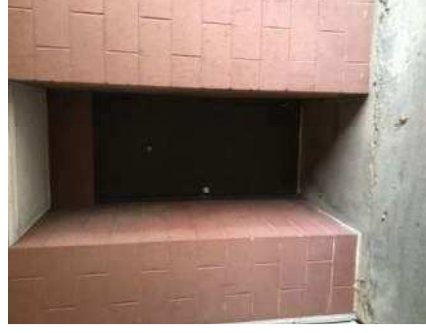
Figure 15c – Ground floor entry door

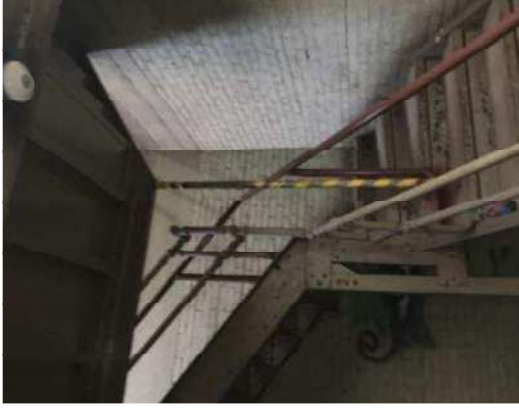
CODE	ITEM	DESCRIPTION	QTY	UNIT	COND.	REMARKS
B1090		Circular stair			vii	The headroom clearance at this point is below the code required 6'-8" minimum (fig 24). This stair does not exit directly to the exterior
		Ramp – interior First Floor	1		i	Connects basement to ground floor. Does not meet code or ADA requirements Ramp at first floor runs in the corridor and is in good condition. The slope appears to meet ADA requirements.
B20		Exterior Vertical Enclosures				
B2010		Exterior Enclosure Walls			iii	The exterior walls have undergone some repairs over the years with a tuck-pointing exercise done in 2013. The facades currently have various areas that will require additional tuck pointing to the brick and terra cotta. Additional areas will require more extensive brick removal and replacement to fix cracked and curved sections.
B2015		Exterior Enclosure Walls - Fairchild Street	1,370	sqft	iii	On this façade, there are a couple areas near the sidewalk level, where brick faces have spalled from freeze-thaw. In general, the façade appears to be performing well, without apparent structural distress. Near the Fairchild/Doty corner, a round column base displays deterioration near the side walk. Wire reinforcing wrapping around the column for the concrete enclosure is very close to the surface and has corroded, causing concrete to fragment. Repair may entail fairly extensive removal of the concrete wrap and reinstallation of reinforcing and concrete encasement.

Figure 24 – NE Stair Headroom issue

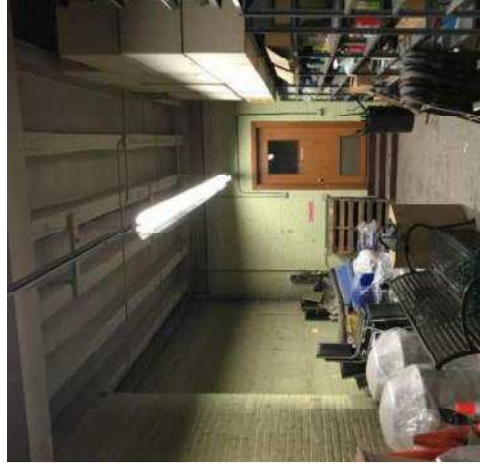
Figure 57 – Storage Door first floor with steps

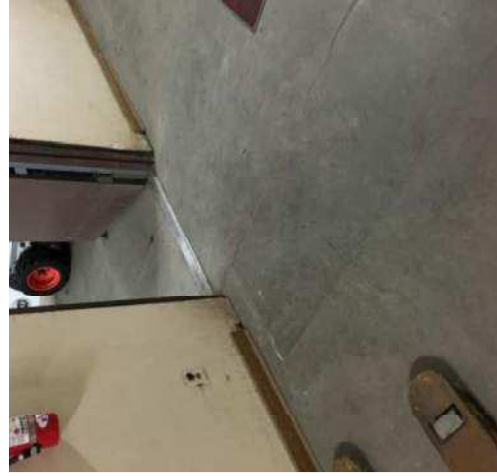
Figure 68 – Ramp in First floor hallway

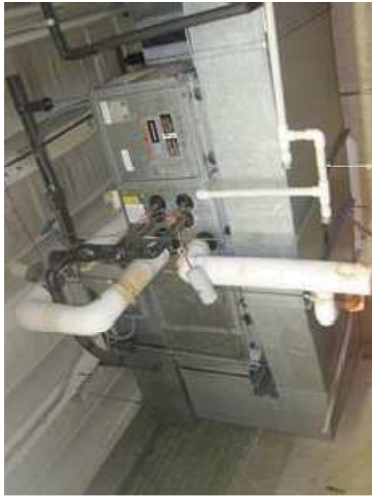
Figure 128 -- AHU Soften Water Tank

D3030	Cooling Systems	Air-cooled condensing units serving only the Upper Level maintenance support areas. The cooling equipment is operational, but at the end of its useful life.			iii	Carrier unit are in fair condition. The unit shall be replaced as the need of function requires.	
D3030.10	Central Cooling			tons	N/A	No district cooling system.	
D3030.70	Decentralized Cooling	There are a number window air-conditioners serving offices.		< 2 Ton	iv	Units are of various ages, size and conditions. They are replaced as the need of function requires.	Fig. 133-128
D3050	Facility HVAC Distribution Systems	AHUs are operational, but at the end of their useful life. There are AHUs for ventilation/heating serving parking/repair areas and air-conditioning unit serving the maintenance support areas.			iv	Units are of various ages, size and conditions. They are replaced as the need of function requires.	Fig. 128-134

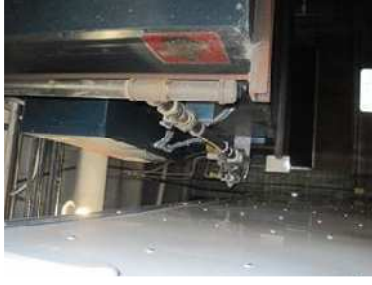
Figure 158 – Makeup Air Unit

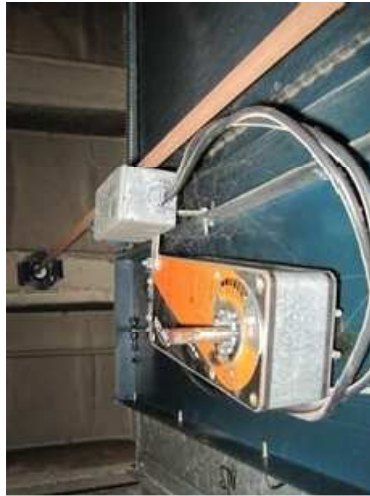
Figure 161 – Electric Actuation on Unit

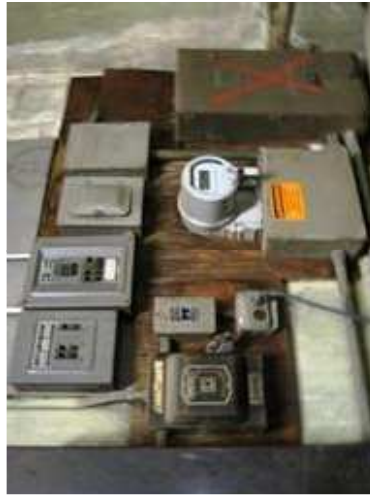
Figure 202 Main Electrical Meter – Main Level

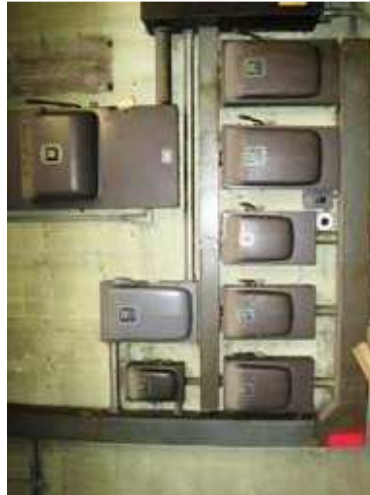
Figure 204 Main Electrical Disconnects – Main Level

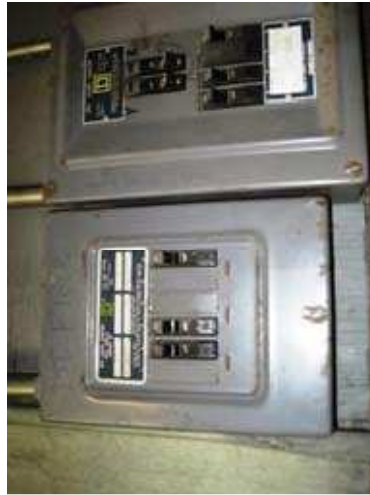
Figure 205 Electrical Sub Panels

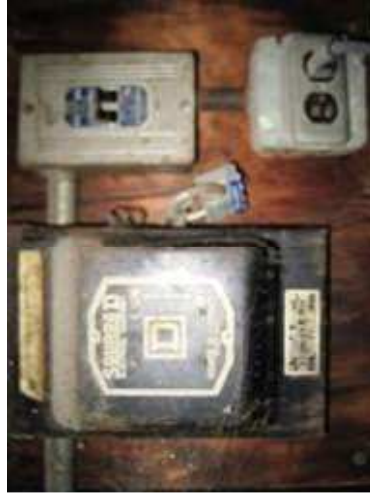
Figure 206 Main Electrical Disconnects – Main Level

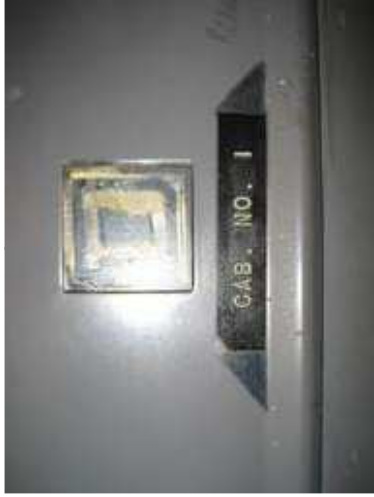
CODE	ITEM	DESCRIPTION	QTY	UNIT	COND.	REMARKS	PHOTOS
<b>D50</b>	<b>Electrical</b>						
D5010	Facility Power Generation	None on-site.		KVA	N/A	No emergency generator on-site.	
D5020	Electrical Service and Distribution	MG&E Service. Electrical distribution is operational.		KVA	v	Electrical distribution may need to be replaced when significant changes to electrical system are made.	Fig. 201-209
D5020.10	Electrical Service	MG&E Service. Electrical distribution is operational, but at end of its useful life.		KW	v	Electrical metering, substations, transformers, switchgear will need to be replaced when changes to system are made.	Fig. 201-209
D5020.30	Power Distribution	120/208V power distribution system is in poor condition. Electrical distribution is operational, but at end of its useful life.		KVA	v	Switchboards, panelboards, bus assemblies, feeders will need to be replaced when changes to system are made.	Fig. 210-250

Figure 210 Electrical Panel No. 1 - Maintenance Area

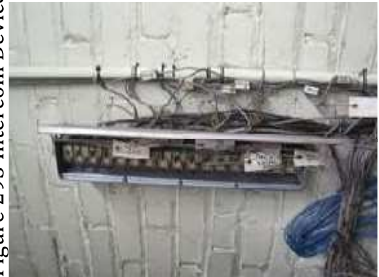
Figure 296 Abandon Telephone Wiring

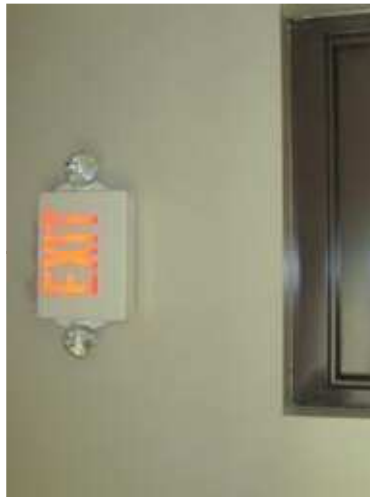
Figure 304 Exit Sign/Emergency Lighting (Battery)

D5030	General Purpose Electrical Power	120/208V power distribution system is in margin condition. Electrical panelboards, wiring and devices has been upgraded, but at end of its useful life.			iv	Branch wiring and devices need to be replaced when change to any system are made.	Fig. 210-250
D5040	Lighting	Lighting has been upgraded in facility with occupancy sensors controls. Lighting Lower level parking garage is margin for adequate light levels. Many facilities are designed to 5 footcandles (horizontal and vertical) with uniformity ratios near 5:1			ii	Upper level lighting is reasonable condition. Recommend potential reuse or repurposing or replacing with new LED fixtures when changes to system are made. For parking areas there are three types of high intensity discharge (HID) fixtures: cutoff, semi cutoff and refractor.	Fig. 254-280 Fig. 300-305
D5080	Miscellaneous Electrical Systems				NA	No Lightning protection on roof.

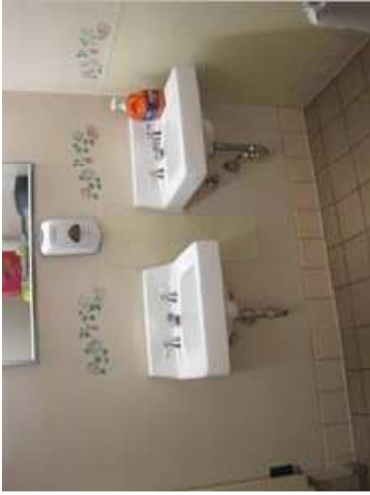
Figure 420 - Women's Wash Sinks

D2010.60	Plumbing Fixtures	Equipment is operational, but at the end of its useful life.			iv	Fixtures need to be replaced when changes to any system are made. Recommend low flow water fixtures.	Fig. 415-423
D2020	Sanitary Drainage	Most of drainage piping is operational, but there is portion of drainage system is at the end of its useful life. Main sanitary drainage was been replaced serving the building and upper garage floor drains.			iii	Any drainage piping will need to be replaced when changes to any system are made.	Fig. 426-431 Fig. 436-463
D2010.10	Sanitary Sewerage Equipment				N/A		
D2020.30	Sanitary Sewerage Piping	Drainage piping is operational, but at the end of its useful life.		Inch	iv	Drainage piping need to be replaced when changes to any system are made.	Fig. 426-431 Fig. 436-463
D2030	Building Support Plumbing Systems				N/A		
D2030.10	Stormwater Drainage Equipment				N/A		
D2030.20	Stormwater Piping	Drainage piping is operational, but at the end of its useful life.		Inch	iv	Drainage piping need to be replaced when changes to any system are made. The storm water exits the building at lower level.	Fig. 426-431 Fig. 468-471

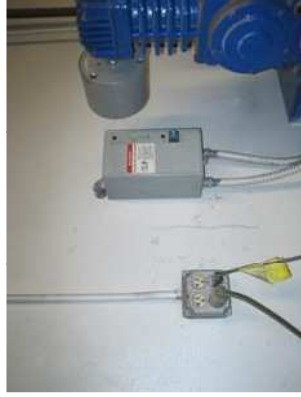
D2060	Process Support Plumbing Systems	Compressor Air in Repair Area on Upper Level is adequate.			i	Compressed air system and hose reels in Shop Area can be relocated.	Fig. 432-434

Figure 434 - Power to Compressor
