Exterior Elevations

Fairchild Building
 Doty Street Lower Elevation
 N.T.S.

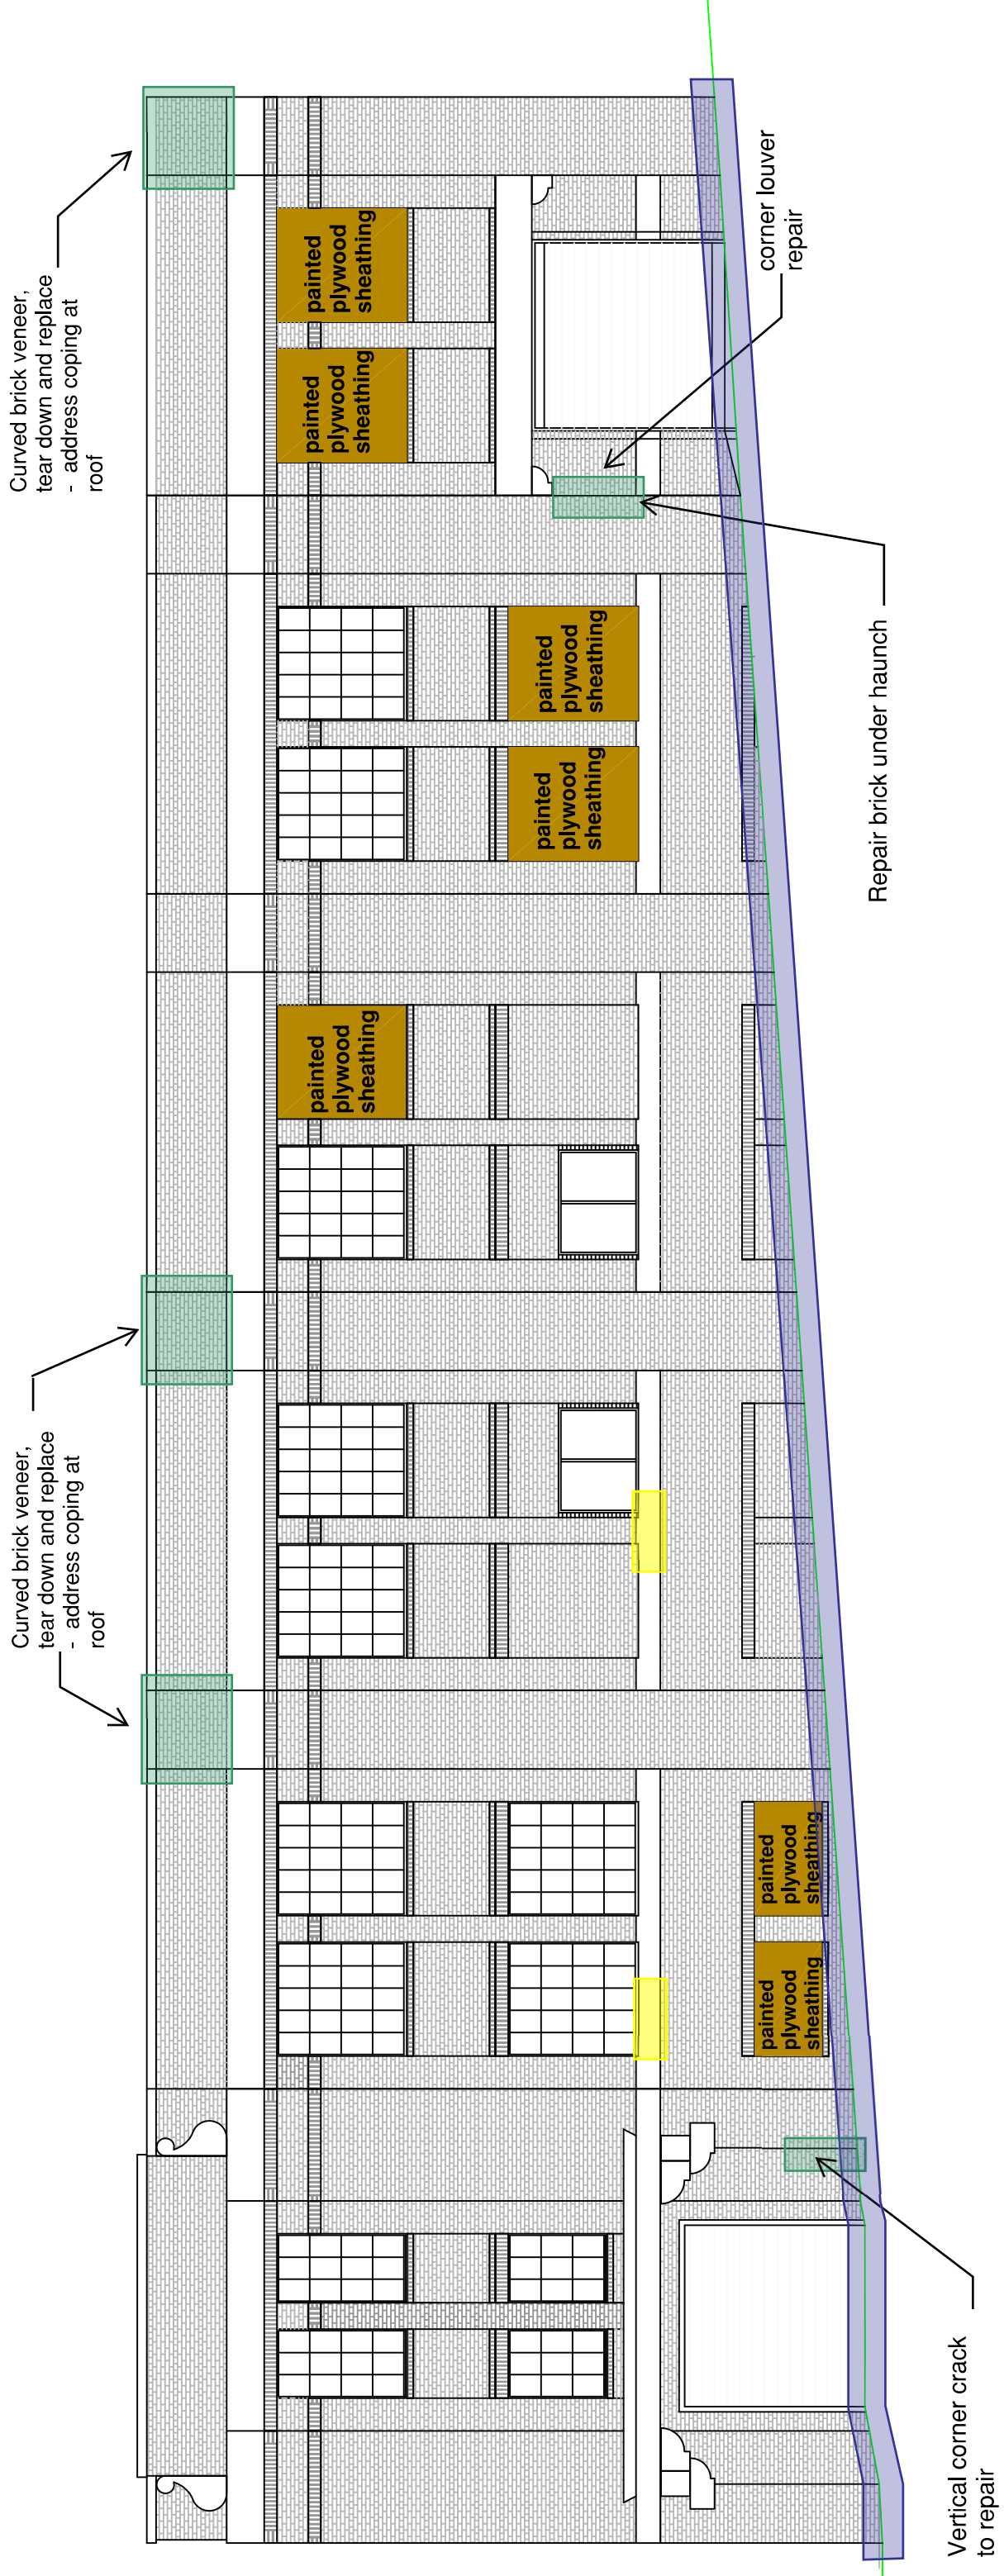
- Brick repair, remove and replace existing damaged bricks
- Terra Cotta repair
- Repoint deteriorated mortar joints. In shaded areas replace damaged, deteriorated, cracked, or spalled bricks
- Address failing joint at wall and concrete curb

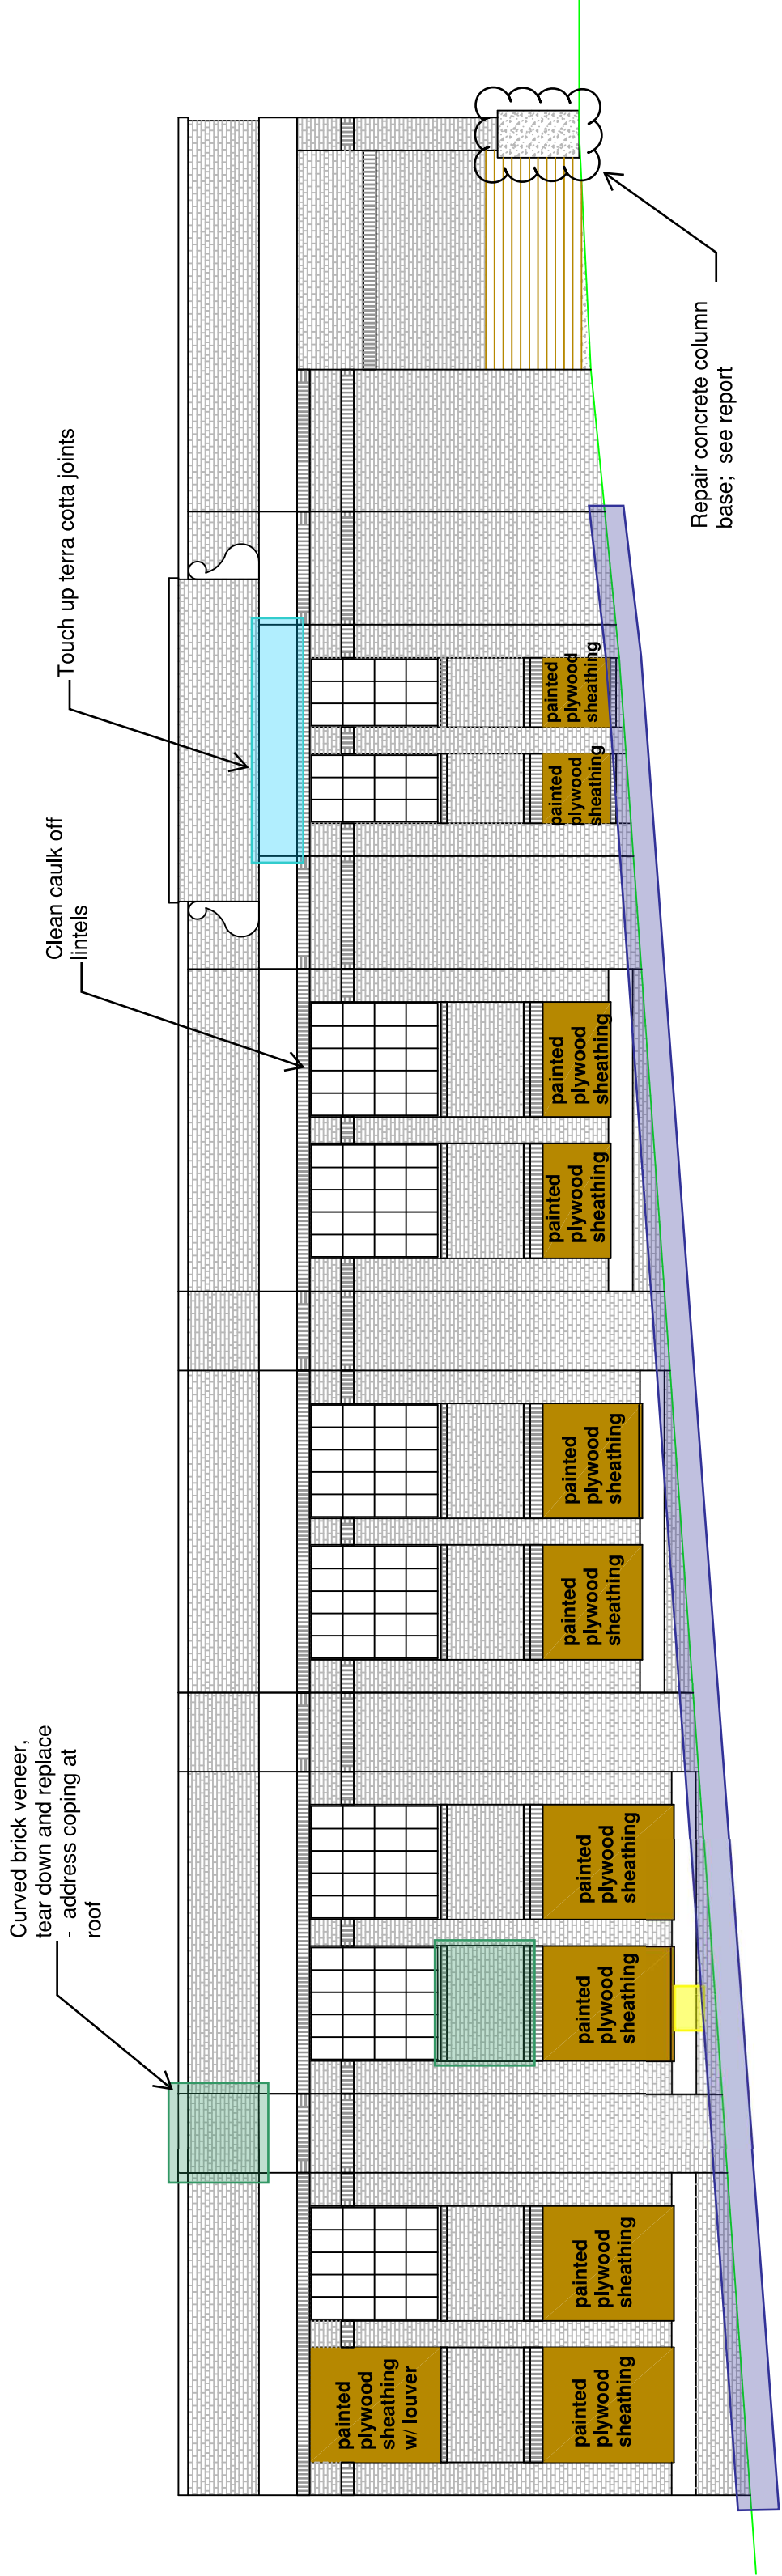
Fairchild Building
 Doty Street Upper Elevation
 N.T.S.

- Brick repair, removed and replace existing damaged bricks
- Terra Cotta repair
- Repoint deteriorated mortar joints. In shaded areas, replace damaged, deteriorated, cracked, or spalled bricks
- Address failing joint at wall and concrete curb

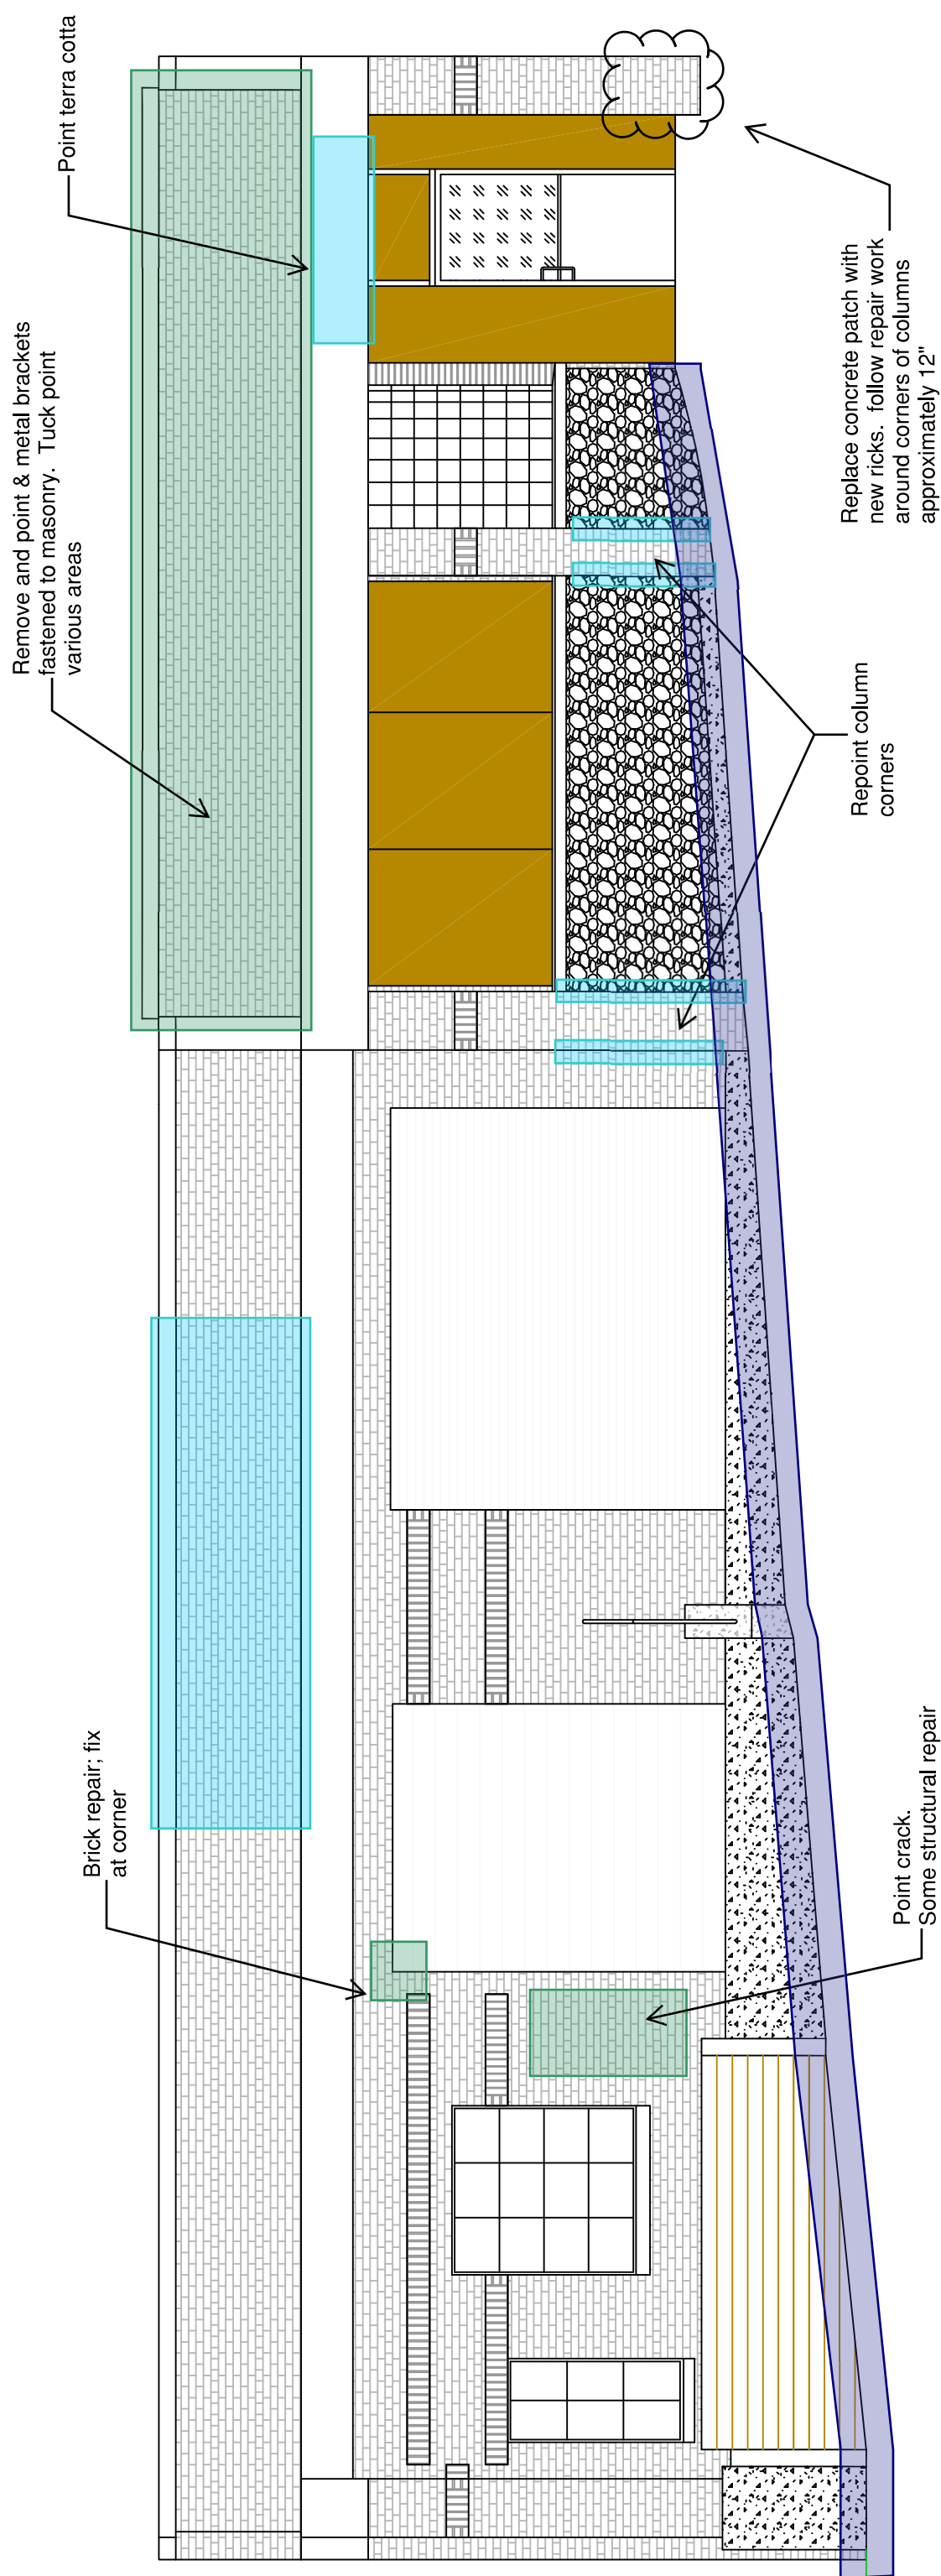
Fairchild Building
 Fairchild Street Elevation
 N.T.S.

- Brick repair, remove and replace existing damaged bricks
- Terra Cotta repair
- Repoint deteriorated mortar joints. In shaded areas, replace damaged, deteriorated, cracked or spalled bricks
- Address failing joint at wall and concrete curb

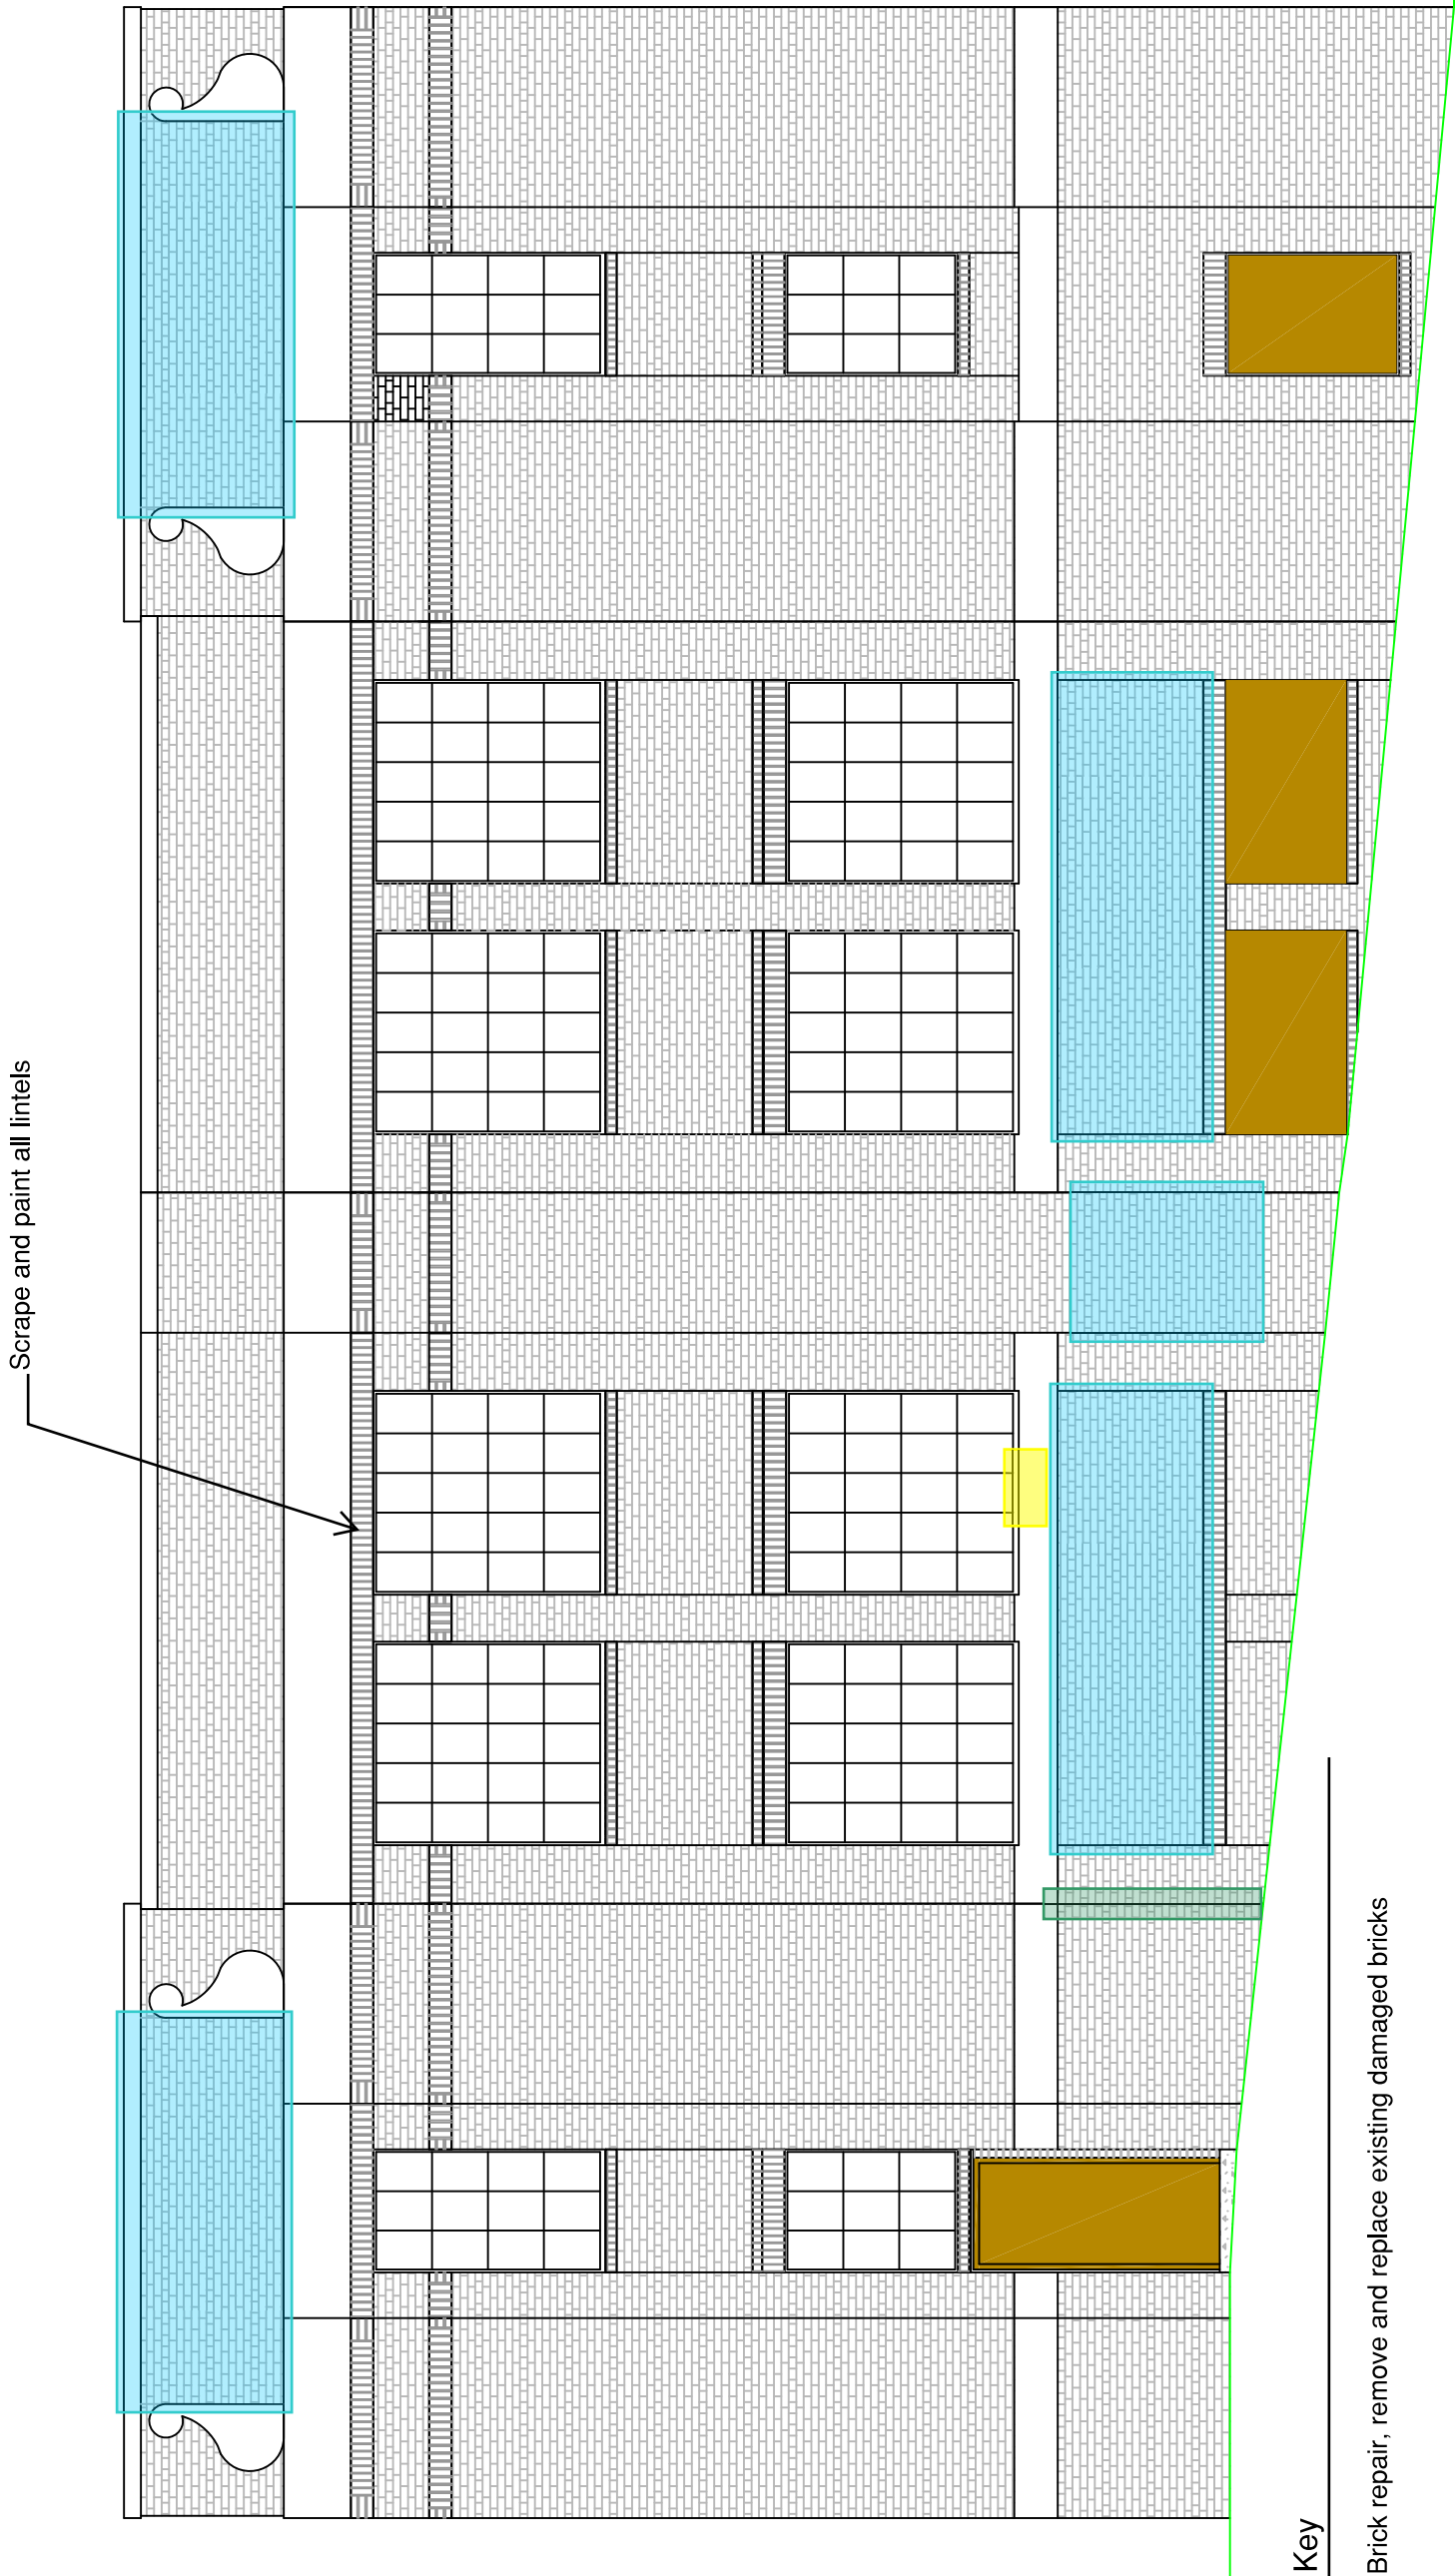
Fairchild Building
 Henry Street Lower Elevation
 N.T.S.

Scrape and paint all lintels

Brick repair, remove and replace existing damaged bricks
-

Terra Cotta repair
-

Repoint deteriorated mortar joints. In shaded areas, replace damaged, deteriorated, cracked or spalled bricks
