## 2. Physical Condition

Institution | City of Madison  
 Building Name | Fairchild Building  
 Building Number | 120 South Fairchild Street

### PHYSICAL CONDITION ASSESSMENT

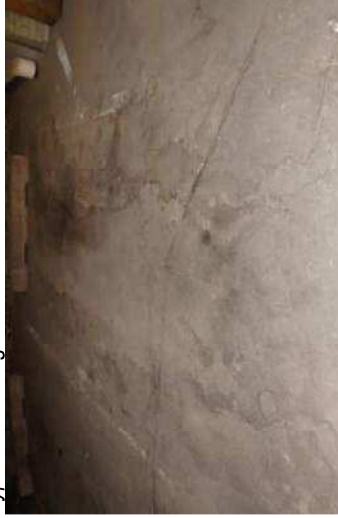
Figure 2

Typical slab-on-grade

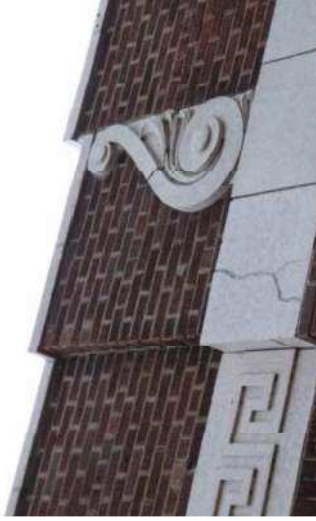
Figure 13

Cracked terracotta tile

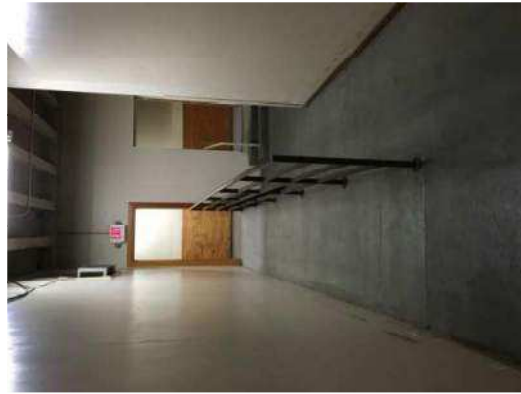
Figure 25 – First floor ramp

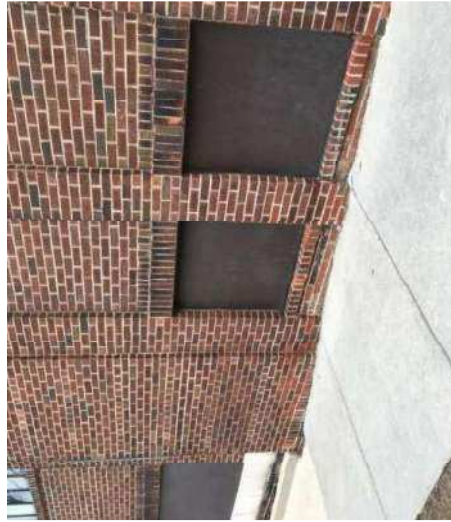
Figure 31 – Exterior window infilled with plywood

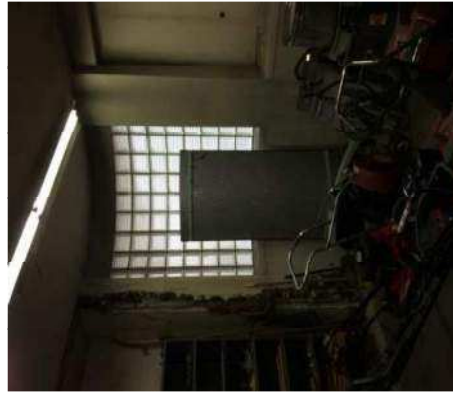
Exterior Windows	Glass Block	1		ii	Located at entry on Fairchild street, not part of the original construction, but installed as a remodel at a date unknown.
B2050	Exterior Doors	Non insulated hollow metal doors.	2		ii	<ul style="list-style-type: none"> <li>SW stair exit door size 3'-0" x 6'-8" h, painted.</li> <li>Ground Floor exit door off Owen Street, size 3'-0" x 6'-8" H exit door adjacent to overhead door – not ADA</li> </ul>
						Figure 14
						Figure 15
						Figure 26 thru 31 See elevations
						Figure 32 & 33
						Figure 34 & Fig. 18

Figure 32 – Glass block window @ entry

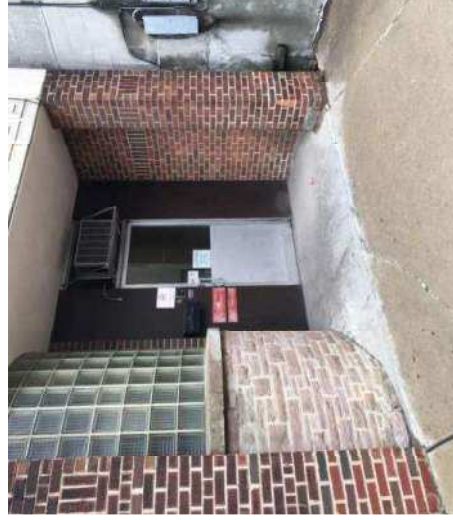
Figure 33 – Exterior image of Glass Block window

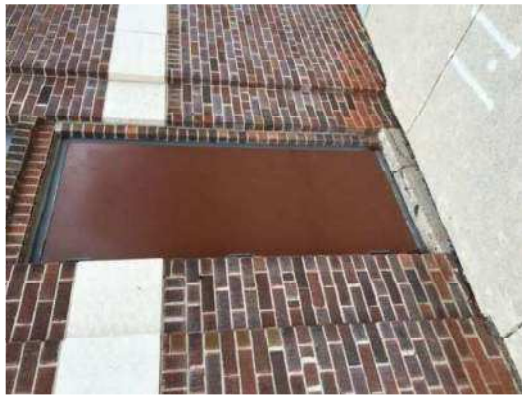
Figure 34 – Exterior stair door

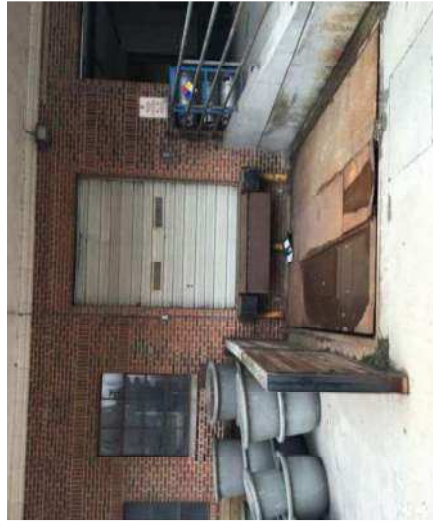
CODE	ITEM	DESCRIPTION	QTY	UNIT	COND.	REMARKS
G2010	Roadways	None				
G2020	Parking Lots	None				
G2060	Site Development	Concrete sidewalk & approaches			iv	Building abuts sidewalk on Henry and Owen Streets. Loading dock and storage area on Fairchild street with concrete approach to front door. Cracking concrete in this area
G2080	Landscaping	None				Fig. 31, 37 & 49

Figure 37 – Overhead Door @ Loading Dock

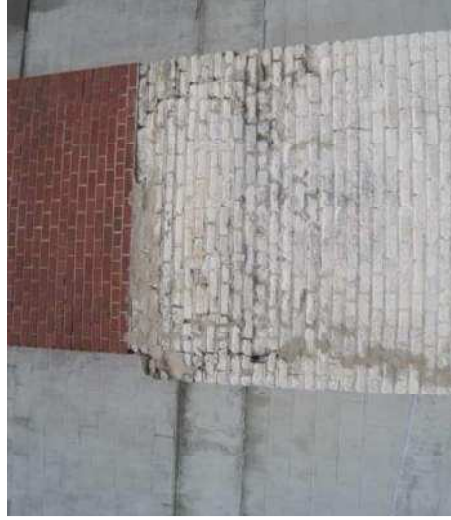
CODE	ITEM	DESCRIPTION	QTY	UNIT	COND.	REMARKS
B2060	Exterior Door	Aluminum entry door	1		vi	Main entry door located on Fairchild street. Single pane glass size 3'-6" x 6'-8" H
	Exterior grilles	Metal louvers for exhaust and intake air	Various		v	(3) existing louvers are located in the brick veneer along Owen Street, 2 from the original design and one added at a later date. The remaining louvers are within the previous window openings which have been covered with plywood.
B2070	Overhead Doors	Automatic roll up coiling metal doors. Non Insulated	(3) first floor (1) ground floor (1) basement		i	Exterior overhead doors located at each level for vehicle access. First floor: (1) 12'-0" wide x 10'-0" high access. (1) 8'-0" w x 10'-0" high at loading dock. Ground floor: (1) 10'-0" wide x 9'-8" h at entry off Owen st Basement: (1) 10'-0" wide x 9'-8" h
<b>B30</b>	<b>Roofing</b>					
B3010	Roofing	EPDM roofing with ballast stone over concrete structure. No apparent insulation.	18,040	sqft	vi	Membrane appears worn with multiple areas of visible repairs. Membrane is "tenting" at areas along the parapet (figs 40 & 41 ). Short boxed column enclosures protrude through roof plane. Perimeter lined with various original and added vent stacks. Existing brick chimney brick work is in poor condition.

Figure 45 – Brick Chimney detail

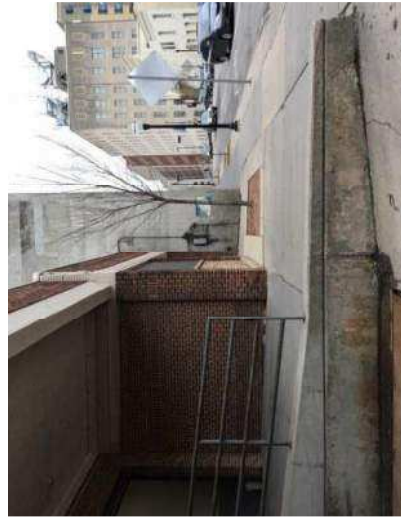
Figure 49 – Soffit @ Loading Dock

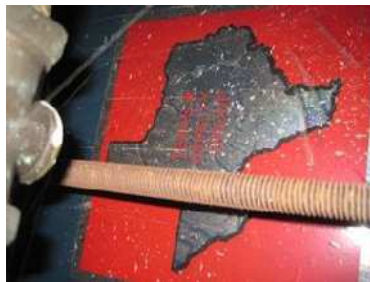
Figure 160– Unit Nameplate

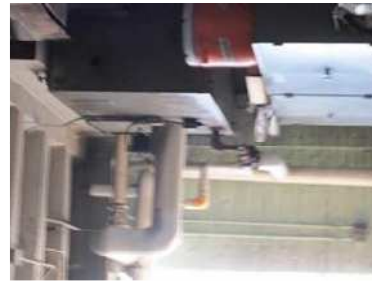
Figure 165 – Makeup Unit

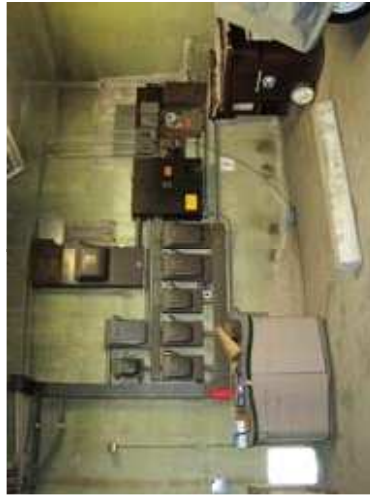
Figure 201 Main Electrical Distribution – Main Level

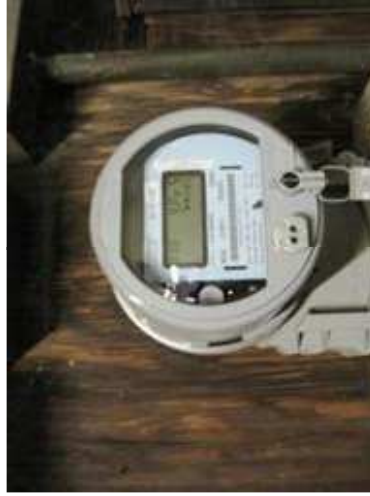
Figure 203 Electrical Meter

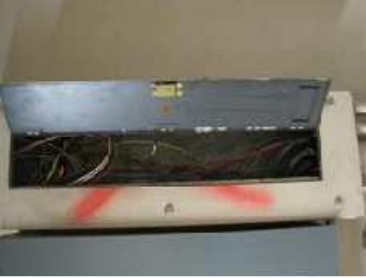
CODE	ITEM	DESCRIPTION	QTY	UNIT	COND.	REMARKS	PHOTOS
<b>D50</b>	<b>Electrical</b>						
D5010	Facility Power Generation	None on-site.		KVA	N/A	No emergency generator on-site.	
D5020	Electrical Service and Distribution	MG&E Service. Electrical distribution is operational.		KVA	v	Electrical distribution may need to be replaced when significant changes to electrical system are made.	Fig. 201-209
D5020.10	Electrical Service	MG&E Service. Electrical distribution is operational, but at end of its useful life.		KW	v	Electrical metering, substations, transformers, switchgear will need to be replaced when changes to system are made.	Fig. 201-209
D5020.30	Power Distribution	120/208V power distribution system is in poor condition. Electrical distribution is operational, but at end of its useful life.		KVA	v	Switchboards, panelboards, bus assemblies, feeders will need to be replaced when changes to system are made.	Fig. 210-250

Figure 224 Old Panel J-Box

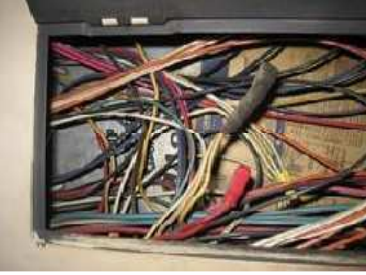
Figure 225 J-Box Wiring

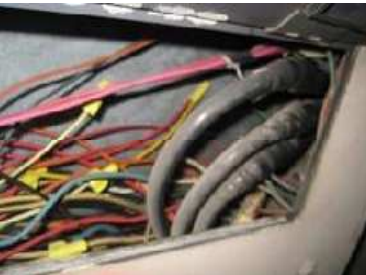
Figure 226 J-Box Wiring

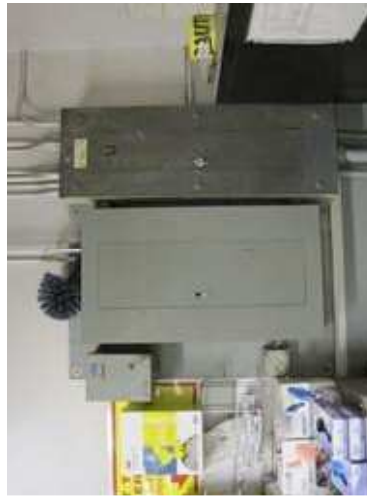
Figure 230 Elect Panel – Maintenance Repair

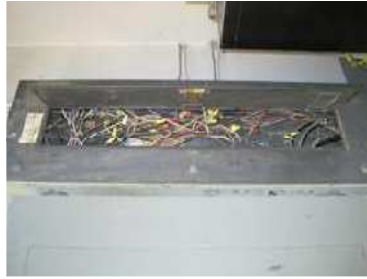
Figure 233 Junction Box

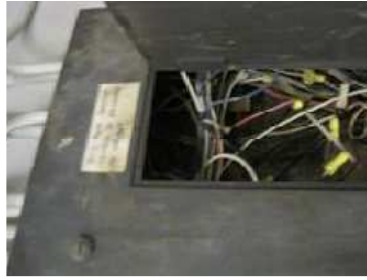
Figure 234 Junction Box

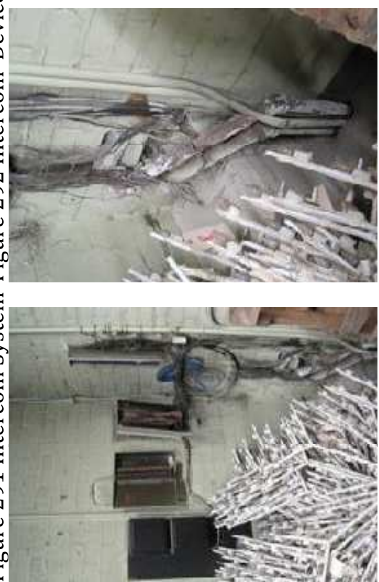
Figure 295 Abandon IT

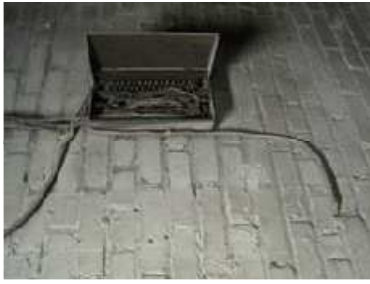
Figure 303 Abandon Panel

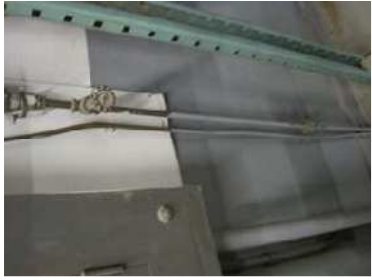
Figure 427 - Water Services

CODE	ITEM	DESCRIPTION	QTY	UNIT	COND.	REMARKS	PHOTOS
D20	<b>Plumbing</b>						
D2010	Domestic Water Distribution	Piping distribution is operational, but at the end of its useful life.			iv	Piping distribution need to be replaced when changes to any system are made.	
D2010.20	Domestic Water Equipment	Equipment is operational, but at the end of its useful life. Existing water heater serves the Upper Level maintenance support areas. There are two existing softeners. One serves the water heater and other is serving the boiler. There is a commercial laundry water heater in the repair garage area.			iv	Equipment need to be replaced when changes to any system are made. Recommend high efficiency water heater and storage for recovery times for the peak demands.	Fig. 408-414
D2010.40	Domestic Water Piping	Equipment is operational, but at the end of its useful life.		Inch	iv	Piping distribution need to be replaced when changes to any system are made.	Fig. 426-431

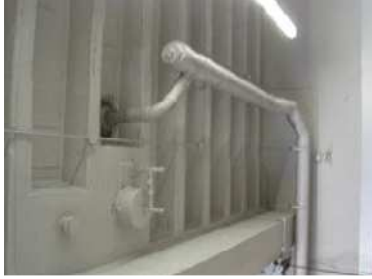
Figure 428 - Sanitary Piping

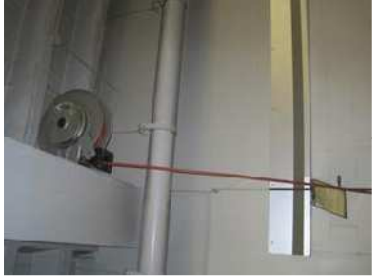
Figure 429 - Compressed Air Reel

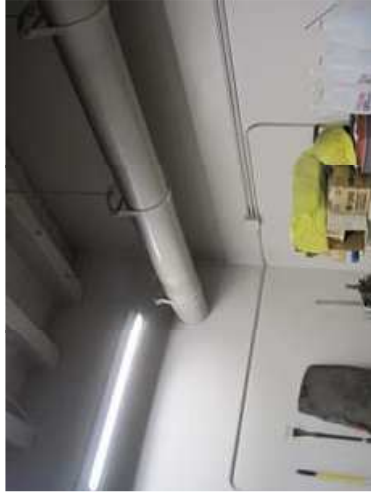
Figure 431 - Sanitary Piping in Main Level

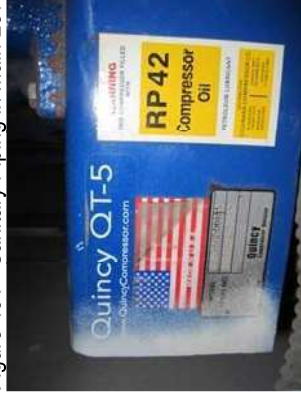
D2060	Process Support Plumbing Systems	Compressor Air in Repair Area on Upper Level is adequate.			i	Compressed air system and hose reels in Shop Area can be relocated.	Fig. 432-434

Figure 433 - Compressor Manufacturer

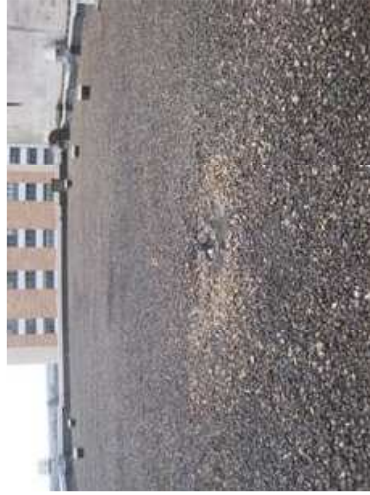
D2010.60	Plumbing Fixtures	Equipment is operational, but at the end of its useful life.			iv	Fixtures need to be replaced when changes to any system are made. Recommend low flow water fixtures.	Fig. 415-423
D2020	Sanitary Drainage	Most of drainage piping is operational, but there is portion of drainage system is at the end of its useful life. Main sanitary drainage was been replaced serving the building and upper garage floor drains.			iii	Any drainage piping will need to be replaced when changes to any system are made.	Fig. 426-431 Fig. 436-463
D2010.10	Sanitary Sewerage Equipment				N/A		
D2020.30	Sanitary Sewerage Piping	Drainage piping is operational, but at the end of its useful life.		Inch	iv	Drainage piping need to be replaced when changes to any system are made.	Fig. 426-431 Fig. 436-463
D2030	Building Support Plumbing Systems				N/A		
D2030.10	Stormwater Drainage Equipment				N/A		
D2030.20	Stormwater Piping	Drainage piping is operational, but at the end of its useful life.		Inch	iv	Drainage piping need to be replaced when changes to any system are made. The storm water exits the building at lower level.	Fig. 426-431 Fig. 468-471

Figure 468 - Roof Drains

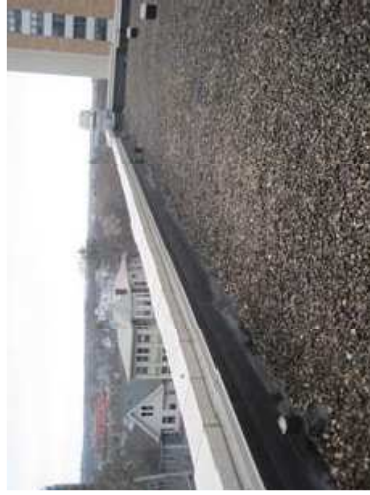
Figure 469 - Roof Vents

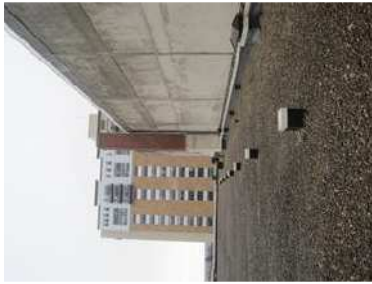
Figure 470 - Roof Area

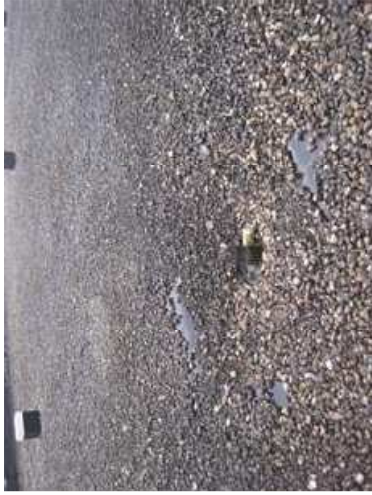
Figure 471 - Roof Drains
